#### DAM SAFETY CERTIFICATE OF COMPLETION

Project location Town/City: Leicester MA Dam name: Cedar Meadow Lake Dam National Dam ID Number: MA00984 State Dam ID Number: 3-14-151-8

Nature of Dam Safety Improvements: Reduction of Leakage

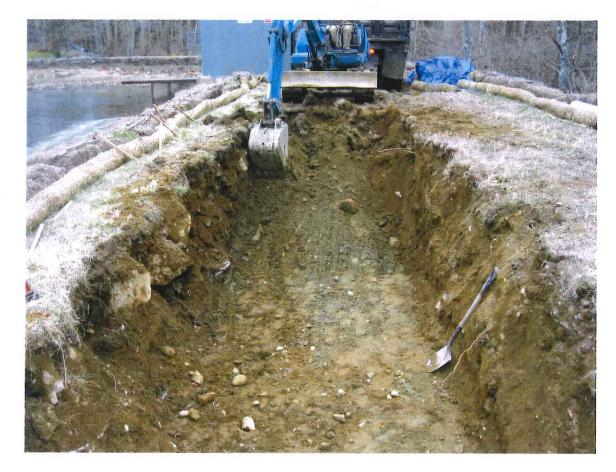
Photo 1 December, 2012

Excavation along crest of dam, looking east from vicinity of spillway sluice wall. Bottom of excavation is original core material. Note overburden on left side of photo (upstream side of dam). Core material was consistently at elevation 882 (1.45+/- feet lower than\_the downstream lip of the spillway). Excavated trench was 7-8 ft wide & 4 ft deep and approximately 35 feet long at the time the photo was taken.

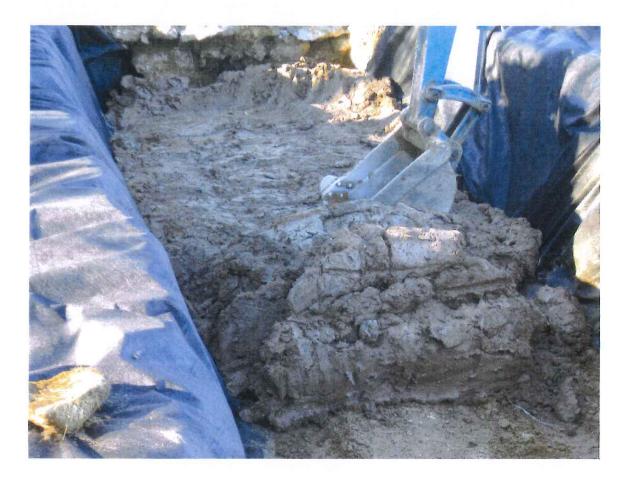
Photo 2 December, 2012

Core cap material being installed in 7+/- ft wide trench. Material had consistency of playdough, but slightly more cohesive. The material had enough cohesion, that after being dumped from the delivery truck it retained the truck body shape with 3.5 to 4 ft high vertical side walls. Geotextile fabric was installed along both upstream and downstream walls of trench to prevent migration or piping of core material. Prior to installation of the core cap, an elevated keyway of original material was formed to prevent a horizontal flow path from forming.

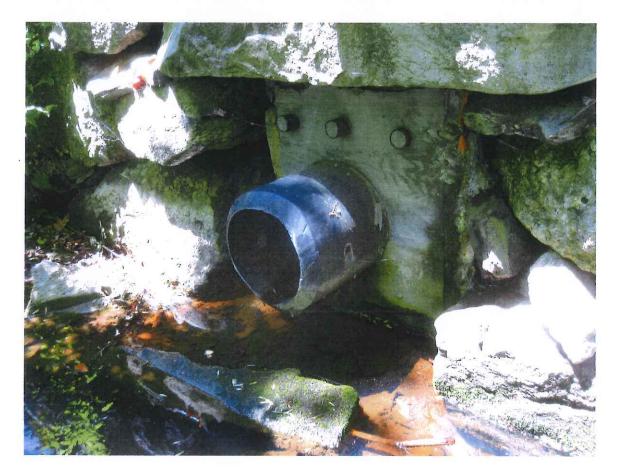
Photo 3 Grouted Annulus between 16-in HDPE & Stone Culvert

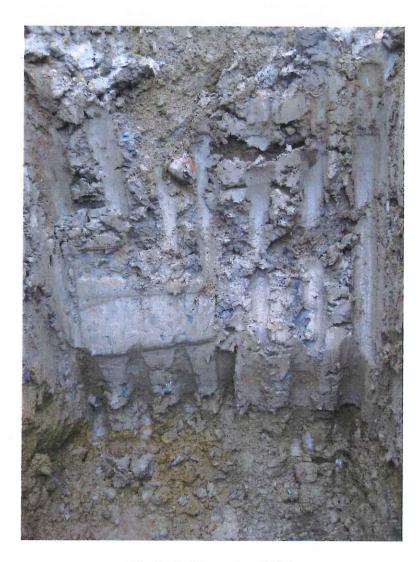
Photo 4 December 2013

December 2012 core wall extension as exposed during December 2013 work. Material placed in December 2013 had a reddish color and not grayish as installed in December of 2012.
