-- CEDAR MEADOW POND DAM --

INSPECTION / EVALUATION REPORT

Dam Name: CEDAR MEADOW POND DAM

Date of Inspection: 5/28/20

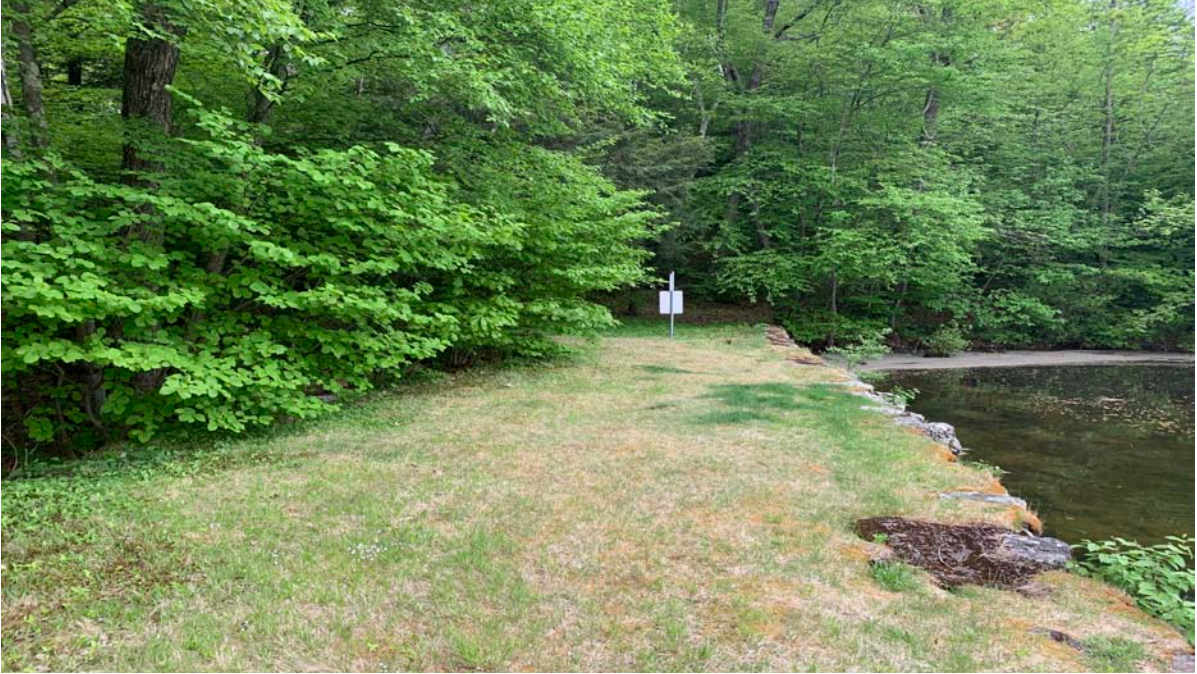
Photo 1: Right abutment from dam crest – Vegetation within 20 feet of the contact mainly on the upstream and downstream sides.

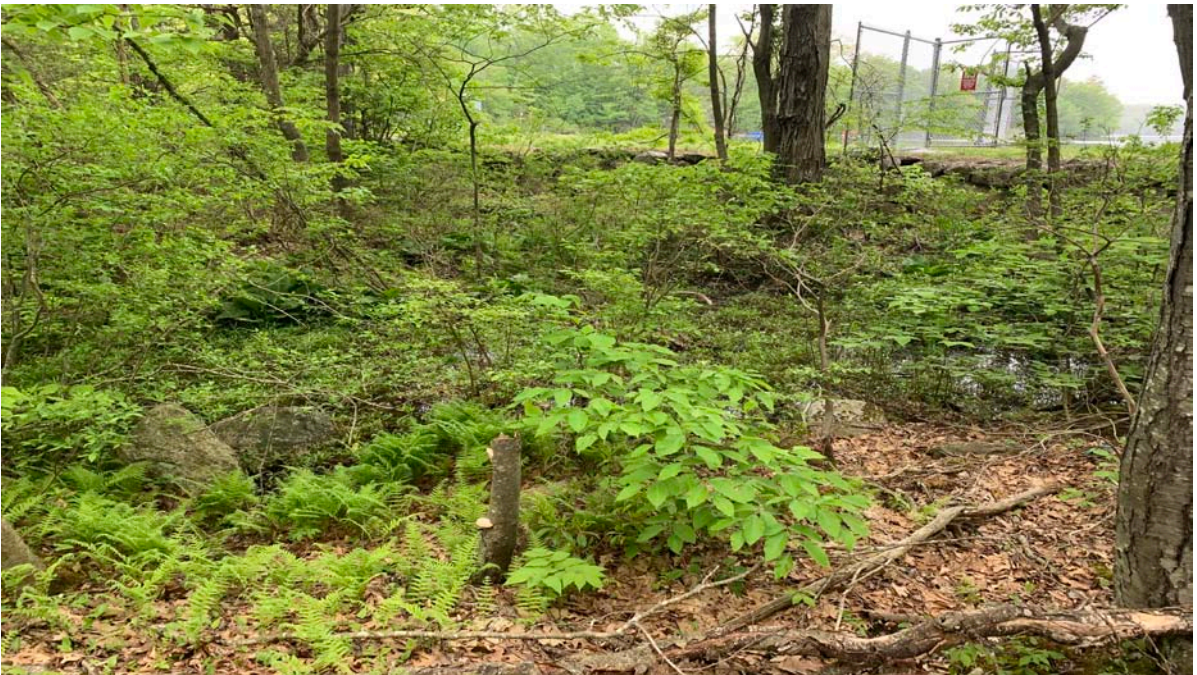
Abutment contact was good at both ends. There was a wet area at the left end of the dam near the abutment contact on the downstream side. At the time of inspection, it was unclear if this area is from seepage through or under the dam. The wet area extends from the left abutment area with flow, although minimal, toward the spillway discharge channel. Vegetation was observed near the right abutment contact primarily on the upstream and downstream sides.

Several wet areas below the dam were observed. At the left end of the dam an area of ponding was observed beginning at the left abutment. Water was flowing minimally in this area toward the spillway discharge channel. The source of the water is not known at this time.

Photo 2: Downstream area at the left abutment – The area is wet with some pooled areas and minimal flow toward the spillway. Photo was taken from Charles Street.

- F. Perform regular monitoring and inspection of the dam and appurtenant structures, including areas of observed seepage, to check for other signs of deteriorating conditions. Complete formal inspections in accordance with current state regulations, which for this structure are required every 5 years;

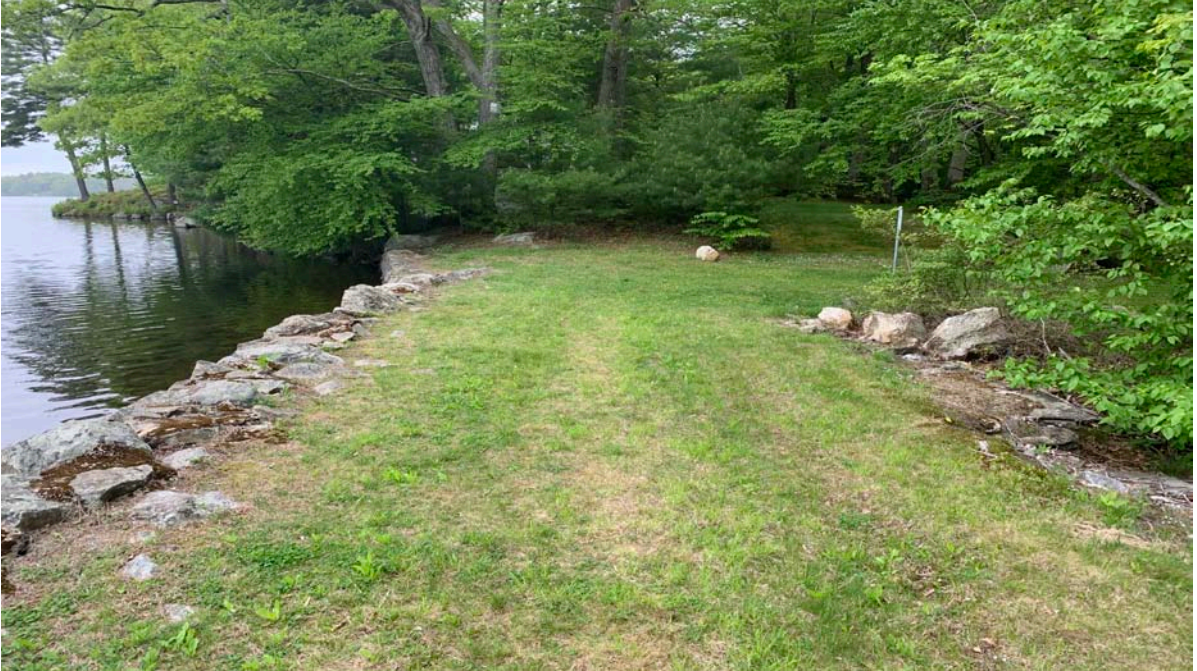
Photo 3: Left abutment from the crest – Minor thin areas of vegetation and shallow tire rutting.

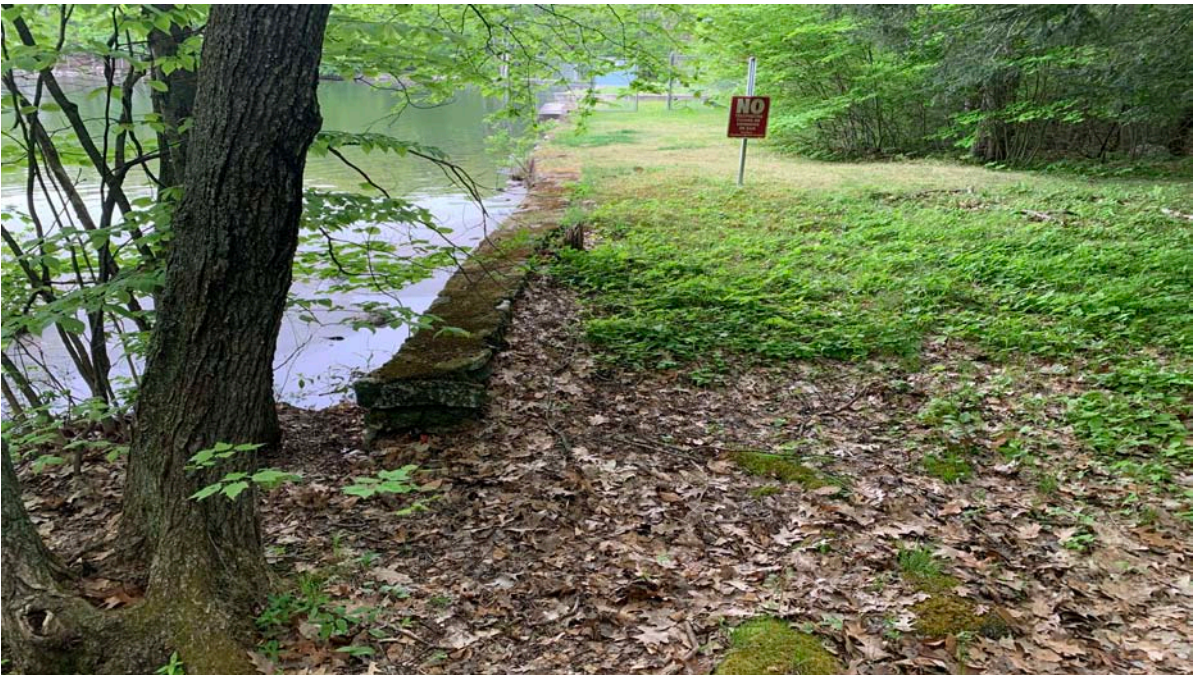
The masonry wall on the upstream face of the dam at the right abutment was observed to be tilted slightly toward the impoundment. This deficiency is minor and likely has little effect on the structural integrity of the dam. Many small voids/animal burrows were observed on the upstream side. No unusual movement was observed due to these voids however these areas should be monitored for any movement of the wall and/or movement within the crest area.

Photo 4: Right upstream face of the dam looking toward the spillway – The upstream wall was leaning outward.

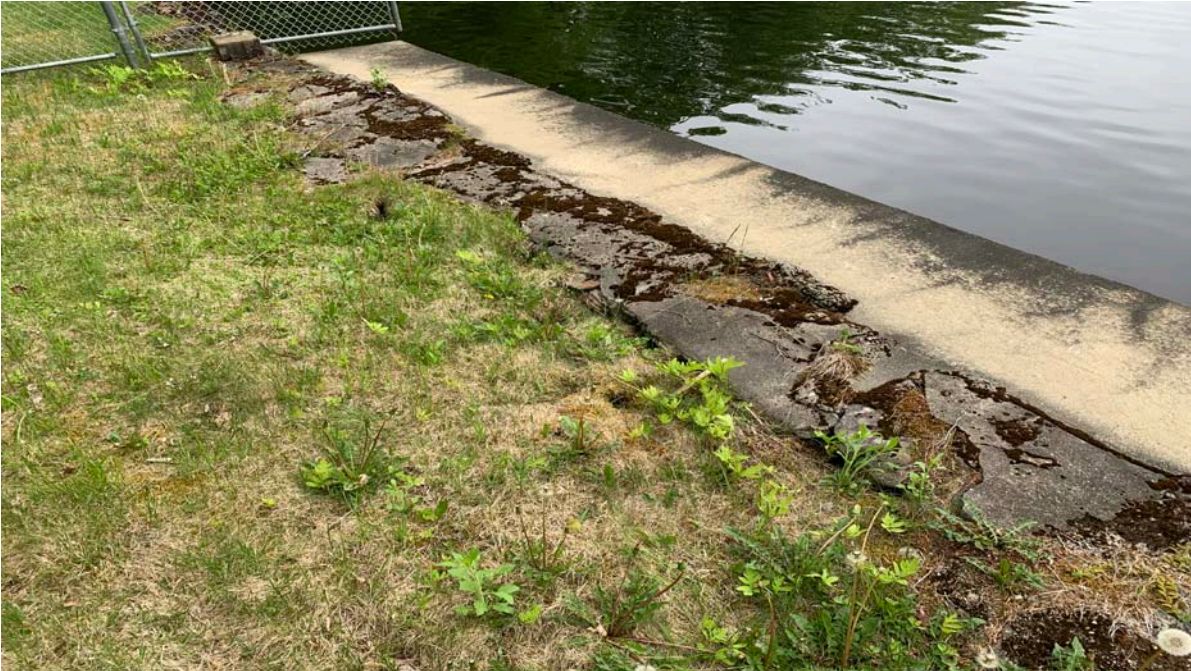
A section of masonry wall at the right abutment was tilted outward towards the impoundment. Animal burrows/small voids were observed behind the upstream masonry walls primarily to the right of the spillway. Very few voids were observed behind the wall along the left side of the dam.

Photo 5: Upstream face between the spillway and the fence on the right crest – Multiple small voids/animal burrows were observed in this area.

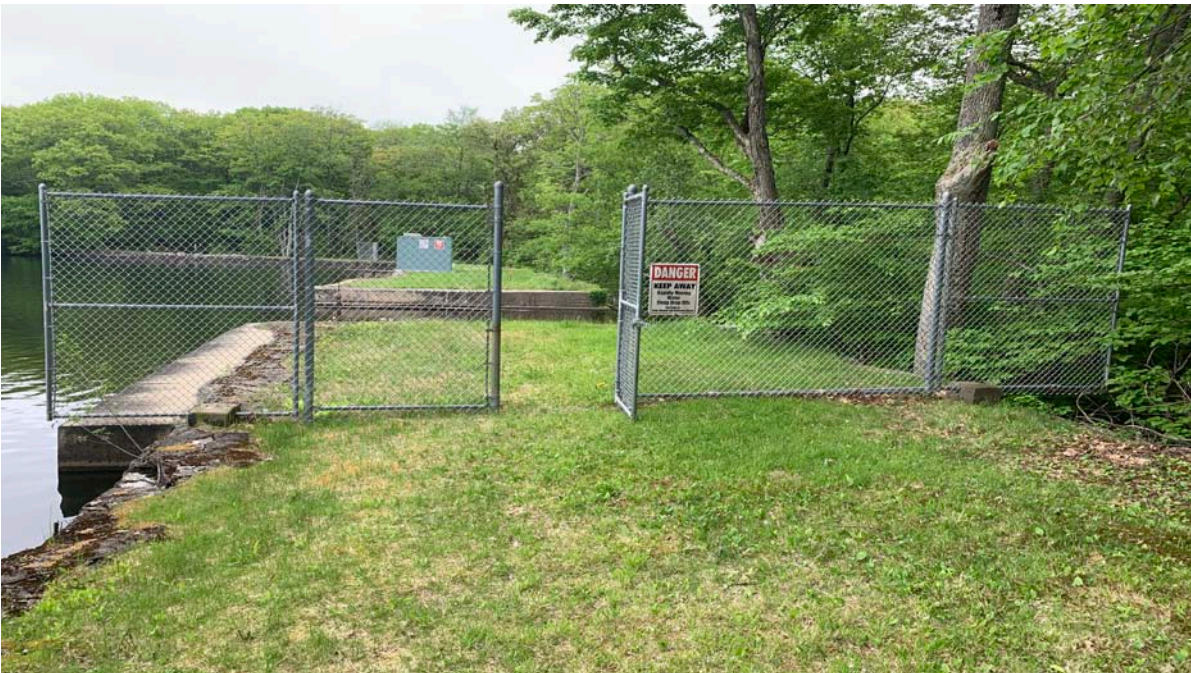
Photo 6: Right crest from the right abutment – There was some thin vegetation along the crest. Note the gate located across the crest.

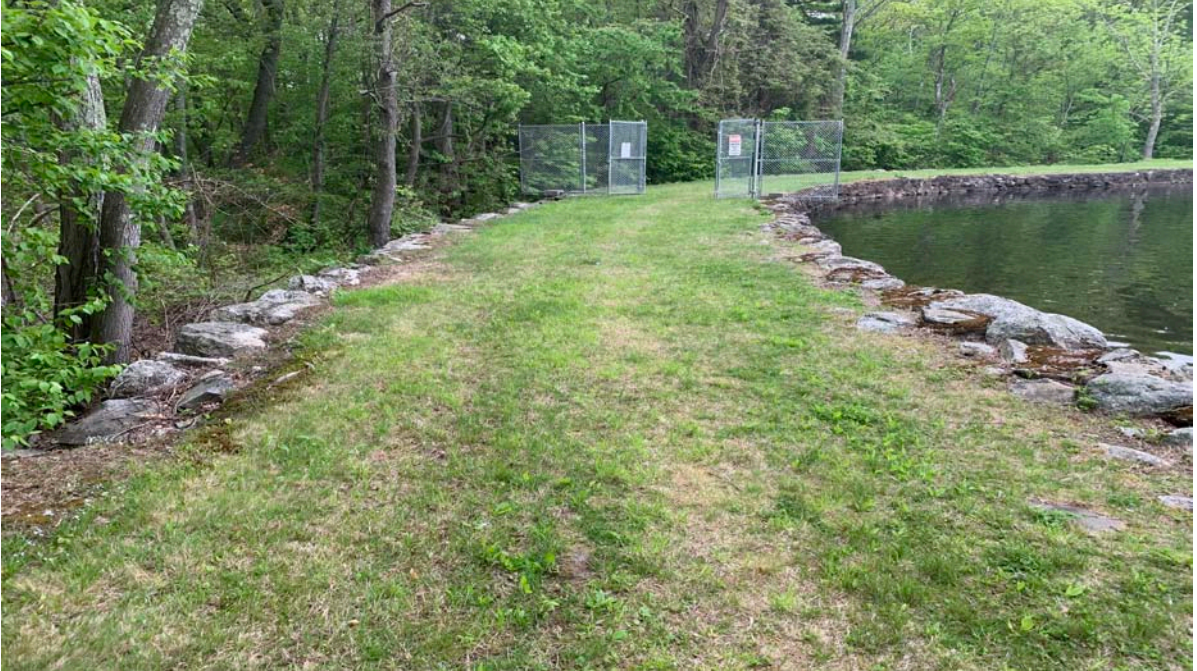
Photo 7: Left crest from the left abutment – There was some thin vegetation along the crest as well as some shallow tire rutting. Note the gate located across the crest.

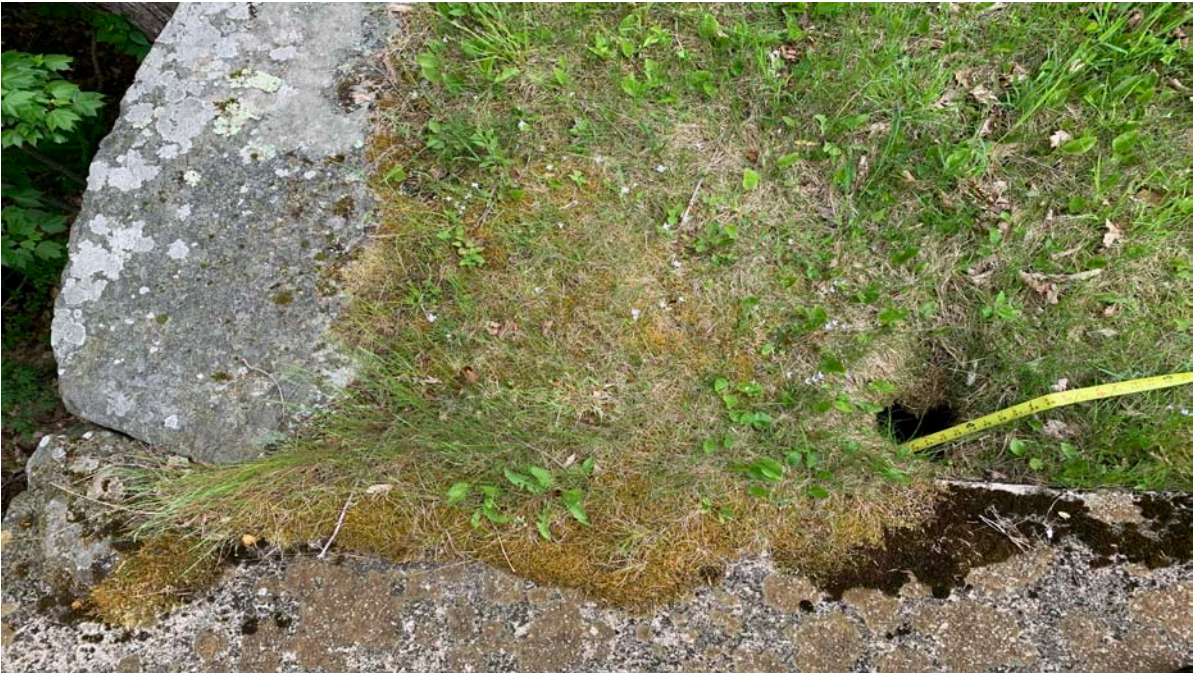
The crest was earth fill with a grass cover over most of the crest with some areas of thin vegetation. Small voids/animal burrows were observed behind the upstream and downstream masonry walls and along the right side of the right spillway training wall. Shallow tire ruts remain on left crest possibly from previous construction projects. A six inch diameter by 2 foot deep void was observed adjacent to the right spillway training wall toward the downstream side.

Photo 8: Void in right crest adjacent to the right spillway training wall.

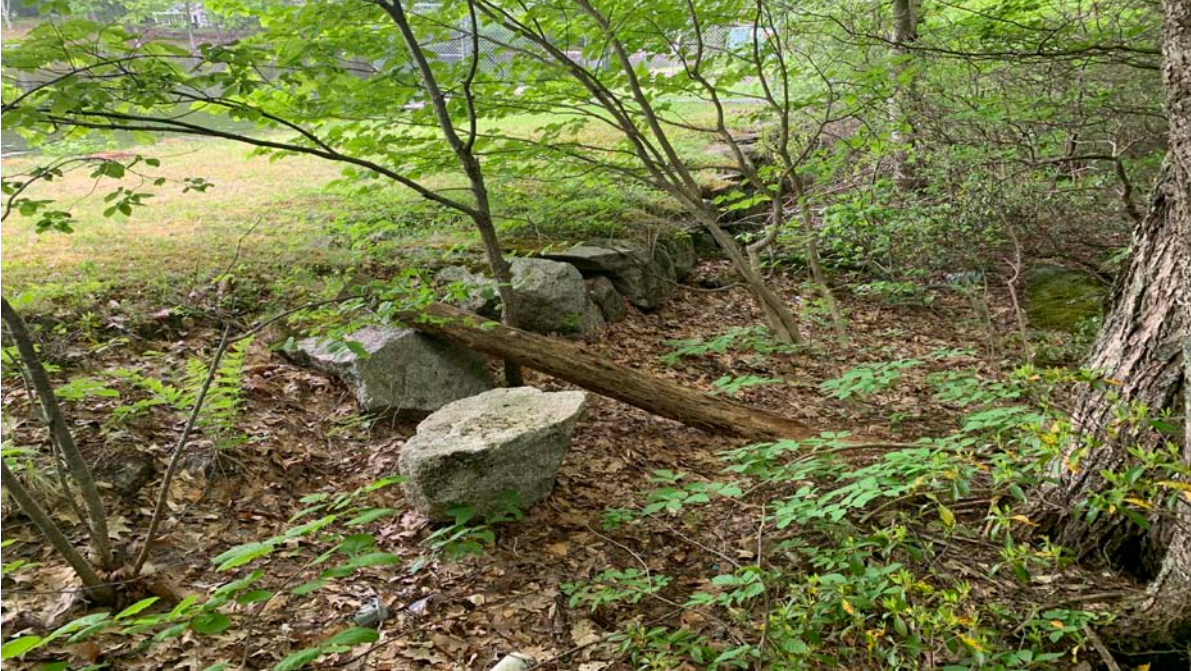
The downstream face of the dam is a near vertical dry stacked masonry wall. There are missing cap stones along top of downstream wall in multiple locations along the right side with only a few locations along the left side. Multiple large trees are growing at the immediate toe of the dam and within 20 feet. The previous report observed that there was flowing water that was audible on the downstream face of the spillway structure (no visible running water). This deficiency was not observed during this inspection.

Photo 9: Right downstream face from the right abutment – Missing cap stones along the top of the wall in multiple locations. Heavy vegetation was observed within 20 feet of the toe.

- G. Replace missing cap stones.

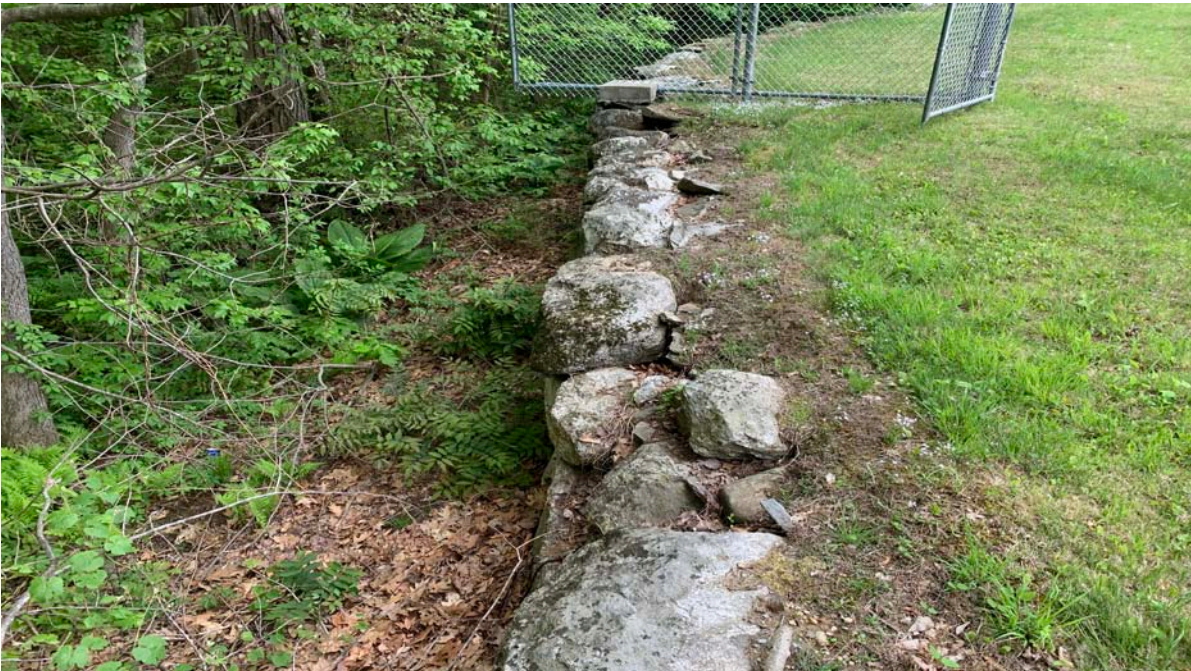
Photo 10: Left downstream face from the left abutment – Missing cap stones along the top of the wall in multiple locations. Heavy vegetation was observed within 20 feet of the toe.

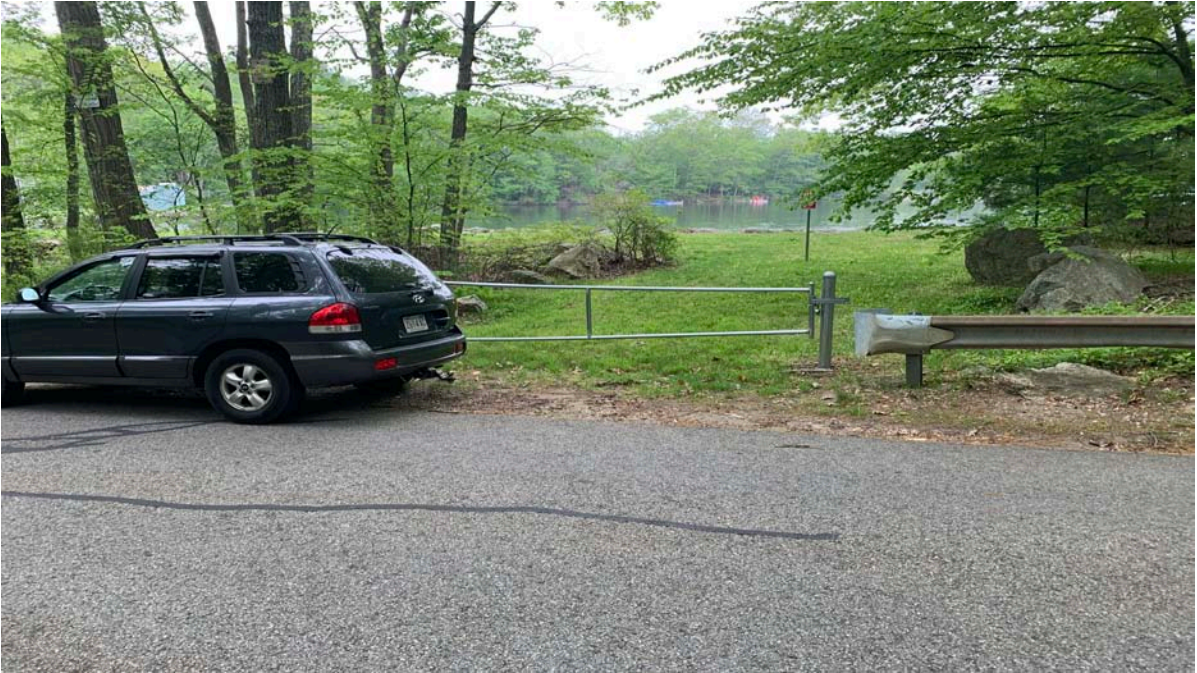
Photo 11: Access to the dam from Charles Street – Entrance is protected from vehicular traffic via a locked swing gate.

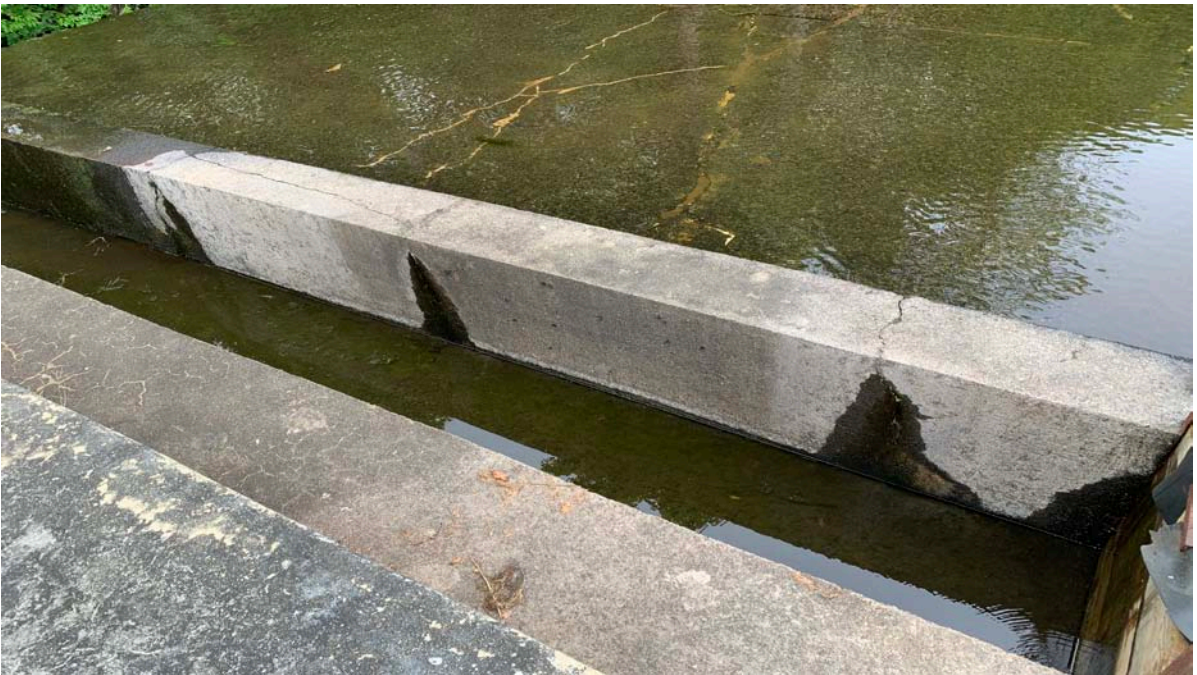
The training wall that is shared between the low flow sluiceway and primary spillway has multiple vertical through cracks with minor seepage into the low flow sluiceway. The low flow sluiceway has the ability to hold approximately five 2x8 weir boards. At the time of the inspection, all weir boards were in place. The owner's representative stated that the weir boards have been replaced recently. No signs of unusual movement were evident. Multiple cracks had been repaired in the spillway crest from previous grout repairs. The previous report observed that there was flowing water that was audible on the downstream face of the spillway structure (no visible running water). This was not observed during this inspection. The water level was approximately 0.7 feet above the left edge of the spillway at the time of the inspection.

Photo 12: Shared wall between primary spillway and low flow sluiceway. Multiple cracks were observed with seepage through the cracks.

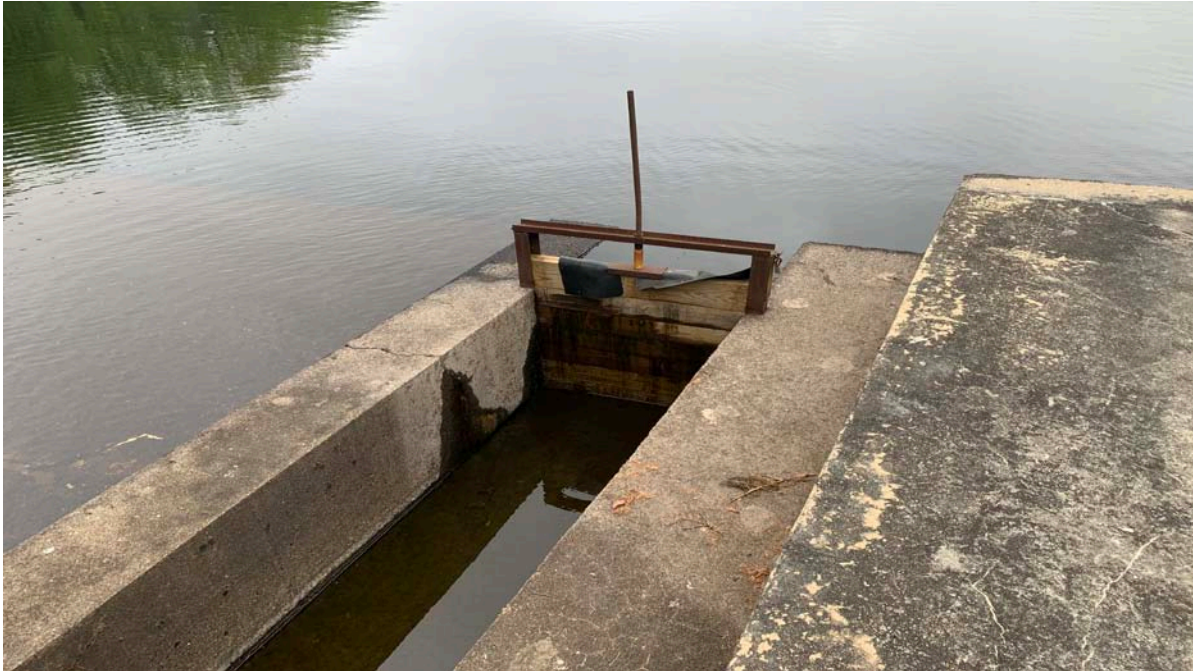
Photo 13: Inlet to the low flow sluiceway – Weir boards were in place at the time of inspection. Weir boards were recently replaced.

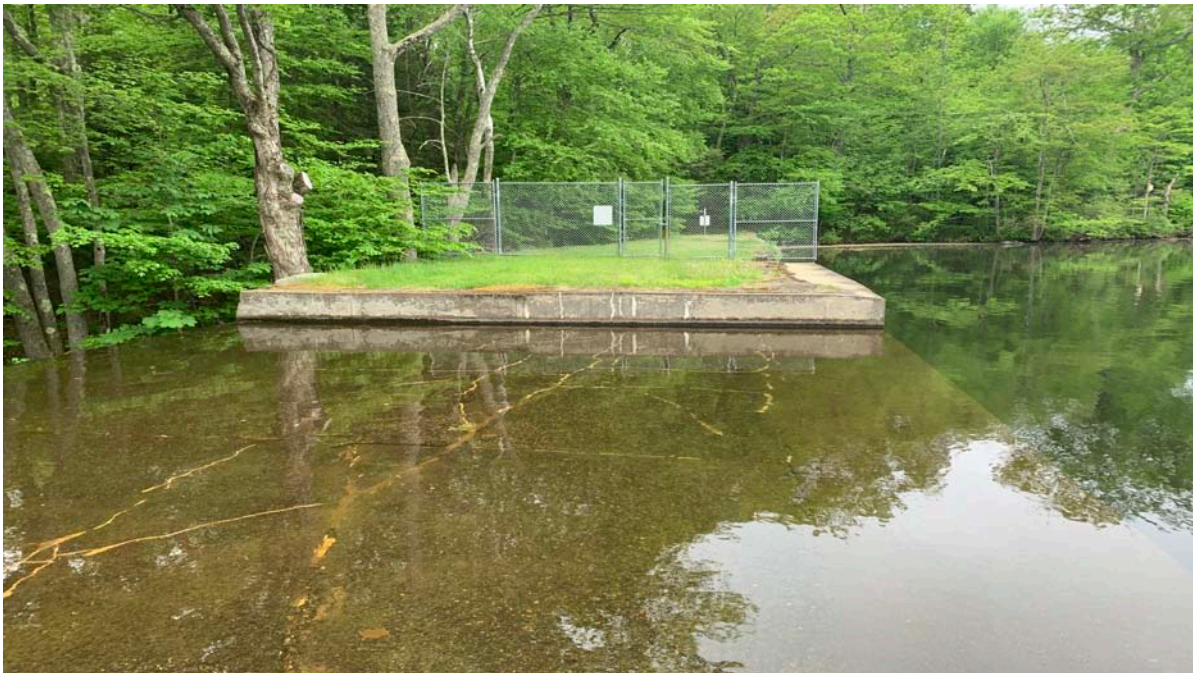
Photo 14: Primary spillway from the left crest – Cracks shown in spillway had been repaired from previous grout repairs. No deficiencies to note during this inspection.

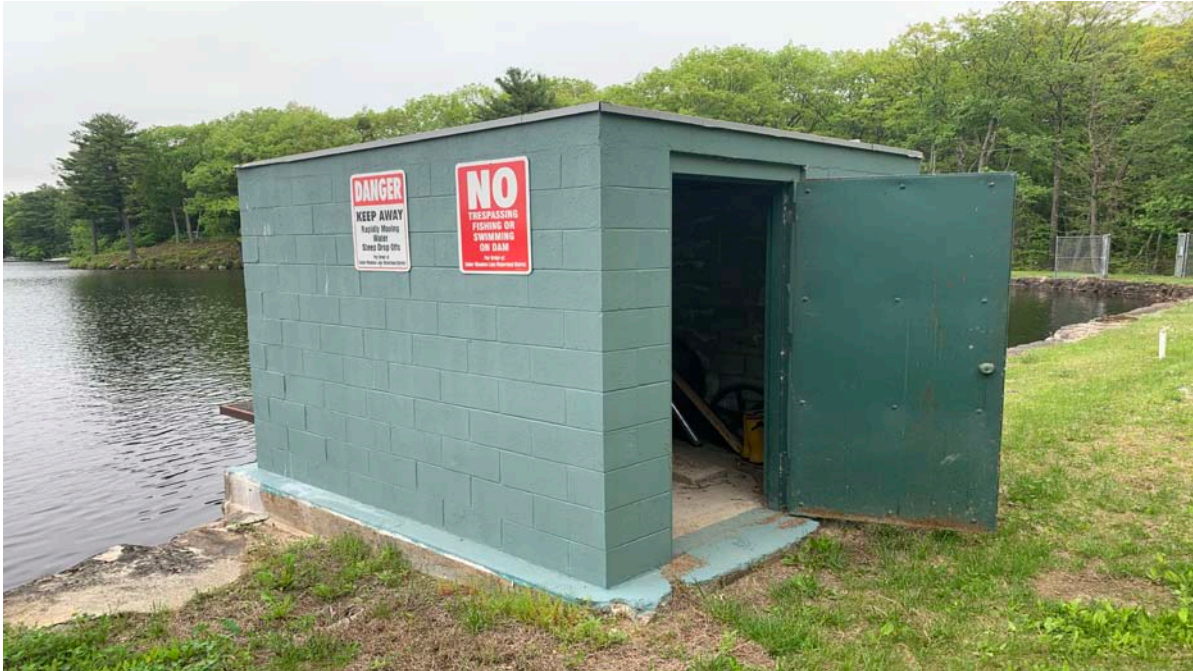
Photo 15: Gate house – The gate house was recently rebuilt but no longer serves a function other than storage. Access to the controls is through this building out onto a cantilever platform.

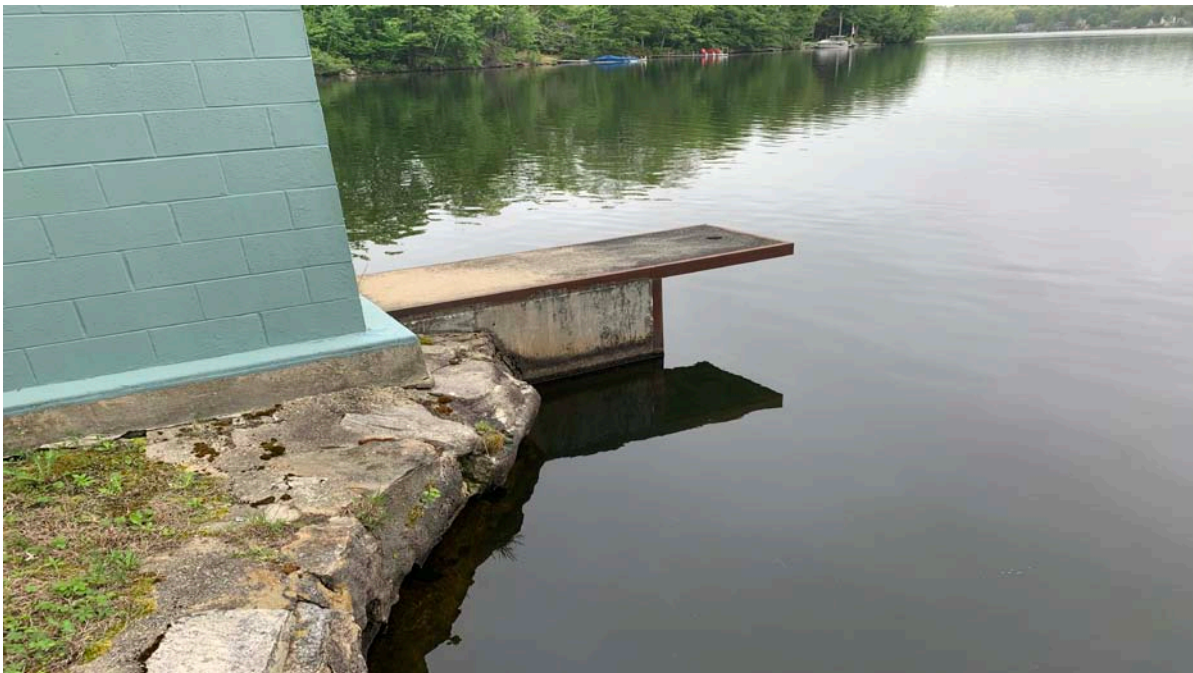
Photo 16: Access to the gate valve for the low level outlet is gained from this cantilevered platform that hangs over the upstream face of the dam.

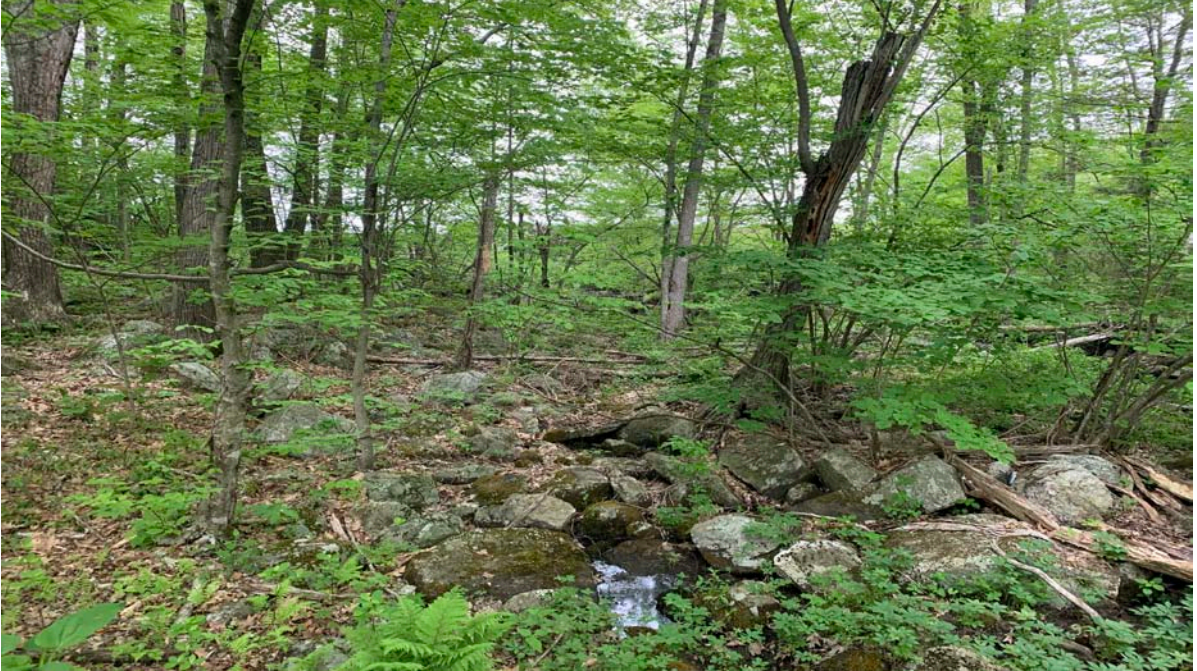
Photo 17: Downstream area along the channel looking back at the dam. The area is heavily vegetated with many trees within 20 feet of the dam toe.
