**Re: Lake Assessment and Management Recommendations – 2020  
Cedar Meadow Lake  
Leicester, Massachusetts  
ESS Project No. C609-003**

### Cedar Meadow Lake 2020 Leicester, Massachusetts

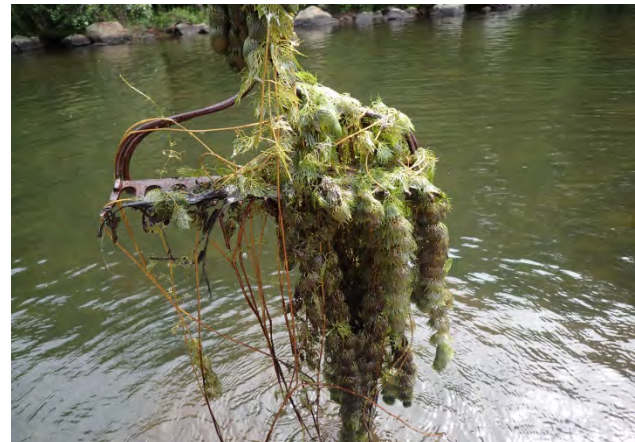
*Fanwort was detected in the main basin of Cedar Meadow Lake for the first time this year, and is currently the most wide-spread of the four non-native aquatic plant species documented in the lake.*

The aquatic plant mapping conducted this year documented two aquatic invasive plant species which had not previously been known to occur in Cedar Meadow Lake: brittle naiad and water chestnut. Additionally, fanwort was documented within the main basin of the lake for the first time this year. Fanwort is currently the most wide-spread aquatic invasive plant species in the lake, and was documented at 22 of 99 (22%) survey locations (Figure 3). Overall fanwort cover throughout the lake is still low, with the only notably dense patch of fanwort located at the northern end of the northeastern cove. Fanwort was also documented near the inlet, along the southwestern shoreline, and at a few other scattered locations. Variable-leaf milfoil was documented at 12 of 99 (12%) survey locations, with the highest density observed in the marsh along the western shoreline (Figure 4). Variable-leaf milfoil was also observed in the northeastern cove and at a few other scattered shoreline locations. Variable-leaf milfoil cover remains largely unchanged compared to the 2018 mapping results. This species was observed at a small number of locations where it was not documented in 2018; however it was not observed this year at a few locations where it was documented in 2018. Variable-leaf milfoil density in the northeastern cove was lower in 2020 compared to 2018, possibly because the species is being out-competed in this area by fanwort. Brittle naiad was observed at two of 99 (2%) survey locations – at the inlet and in the western marsh – and was found at low densities at both locations (Figure 5). Water chestnut was found only at one survey location (1%) and only two stems of the plant were observed (Figure 6). ESS hand-pulled the water chestnut stems and disposed them offsite. Both brittle naiad and water chestnut were very limited geographically within the lake and were growing at very low densities at the locations where they were found. Both of these characteristics indicate that these species have entered the lake recently and are not yet well-established.

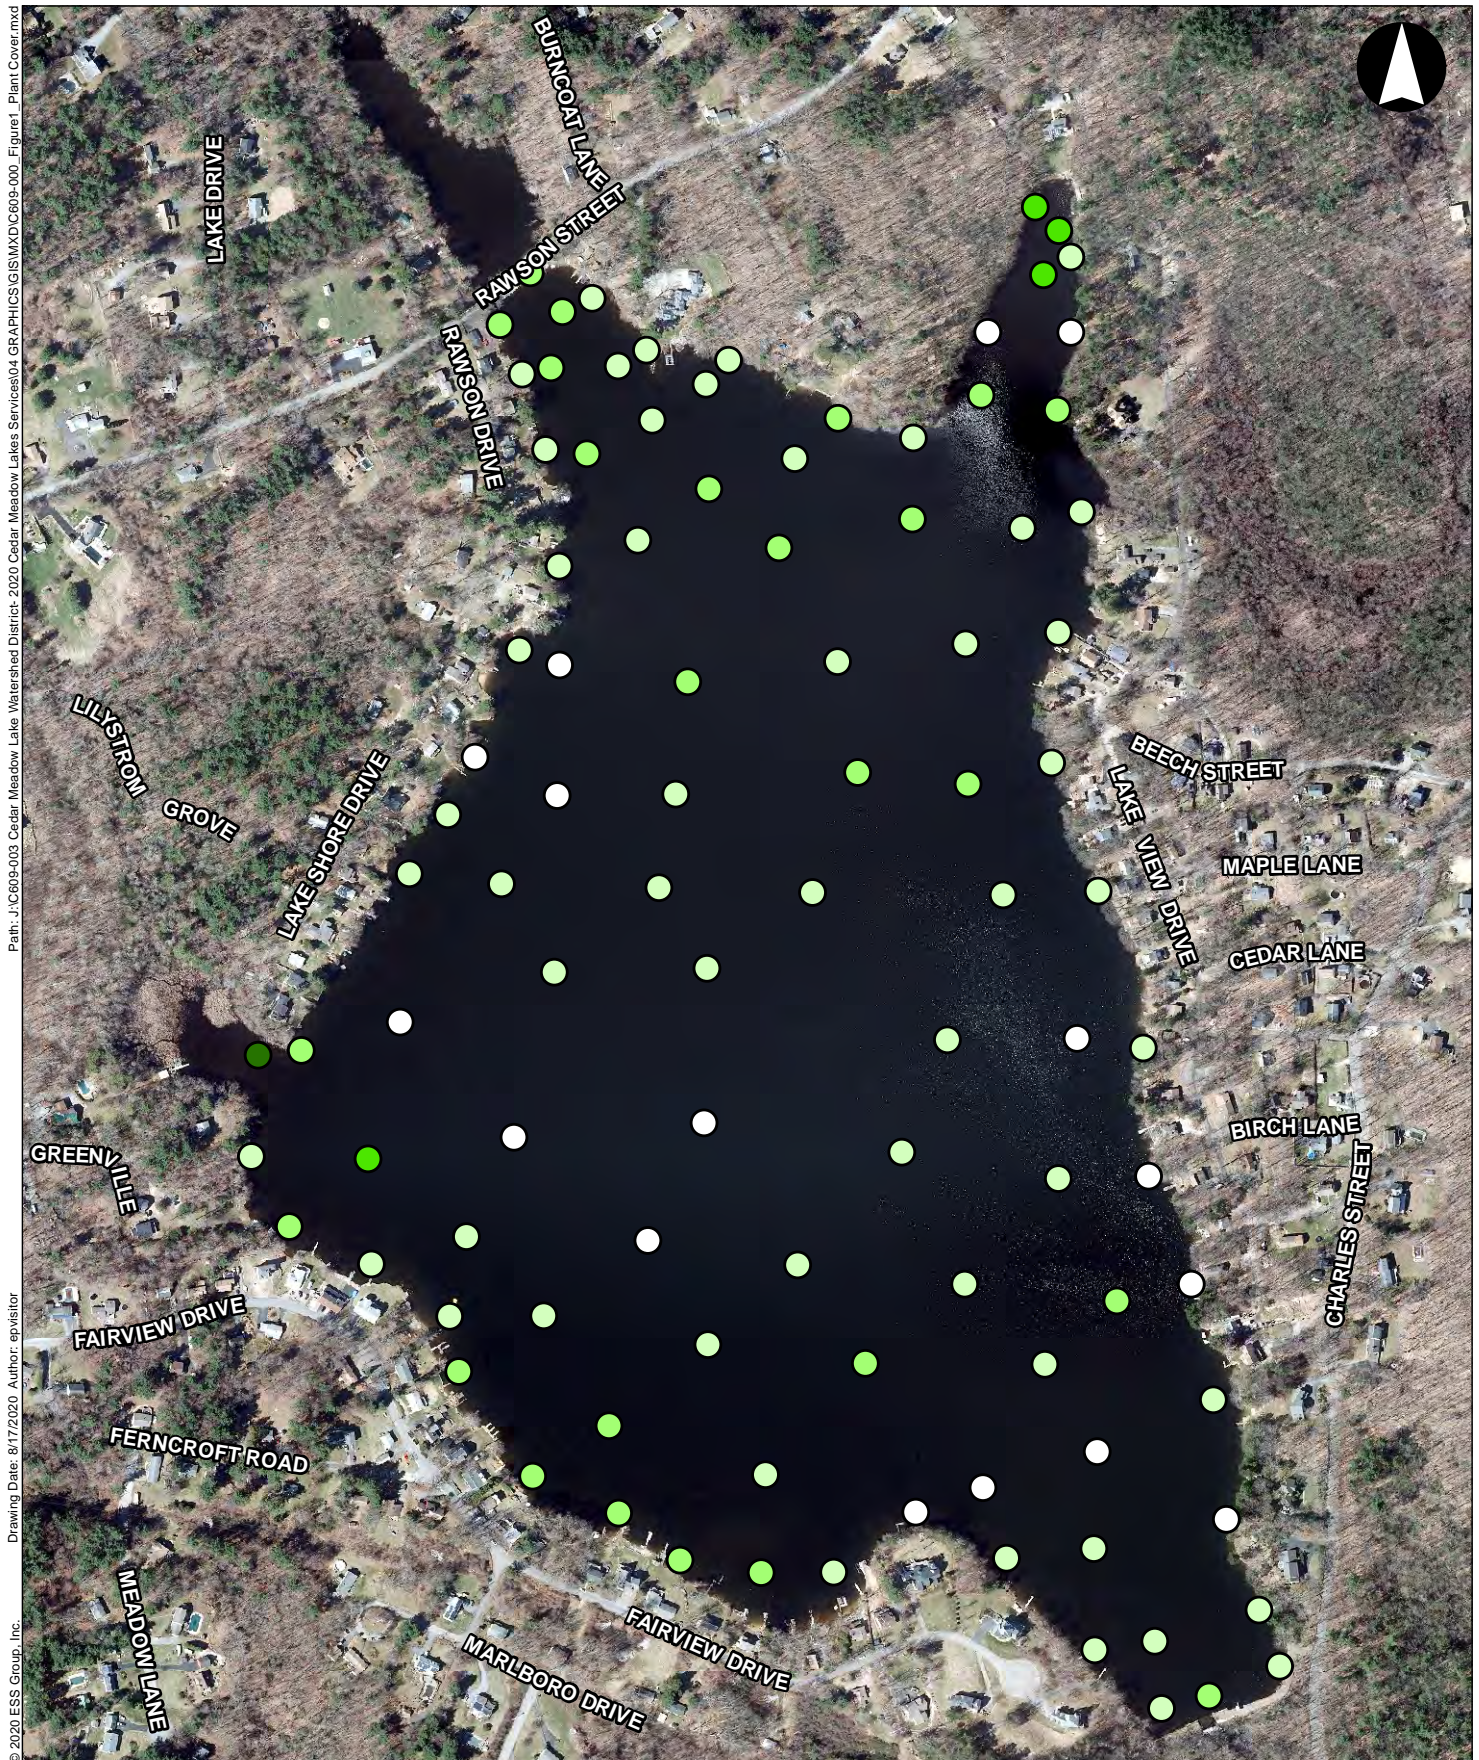
Figure 1

As in past years, aquatic plant cover (a measure of the two-dimensional extent of plant growth across the lake) was generally low (Figure 1). Aquatic plant cover exceeded 50% only in the northeastern cove and in the small marsh located on the western side of the lake. Throughout most of the lake, aquatic plant cover was 25% or less. Aquatic plant biovolume (a measure of the three-dimensional extent of plant growth through the water column) was similarly low and never exceeded 50% (Figure 2). Aquatic plant biovolume exceeded 25% only at two locations: near the inlet at Rawson Street and in the marsh on the

western shoreline. These results suggest that the overall extent of aquatic plants in Cedar Meadow Lake is currently low to moderate, and unlikely to impair recreational uses of the lake such as boating, fishing, and swimming.

### Aquatic Plant Cover August 6, 2020

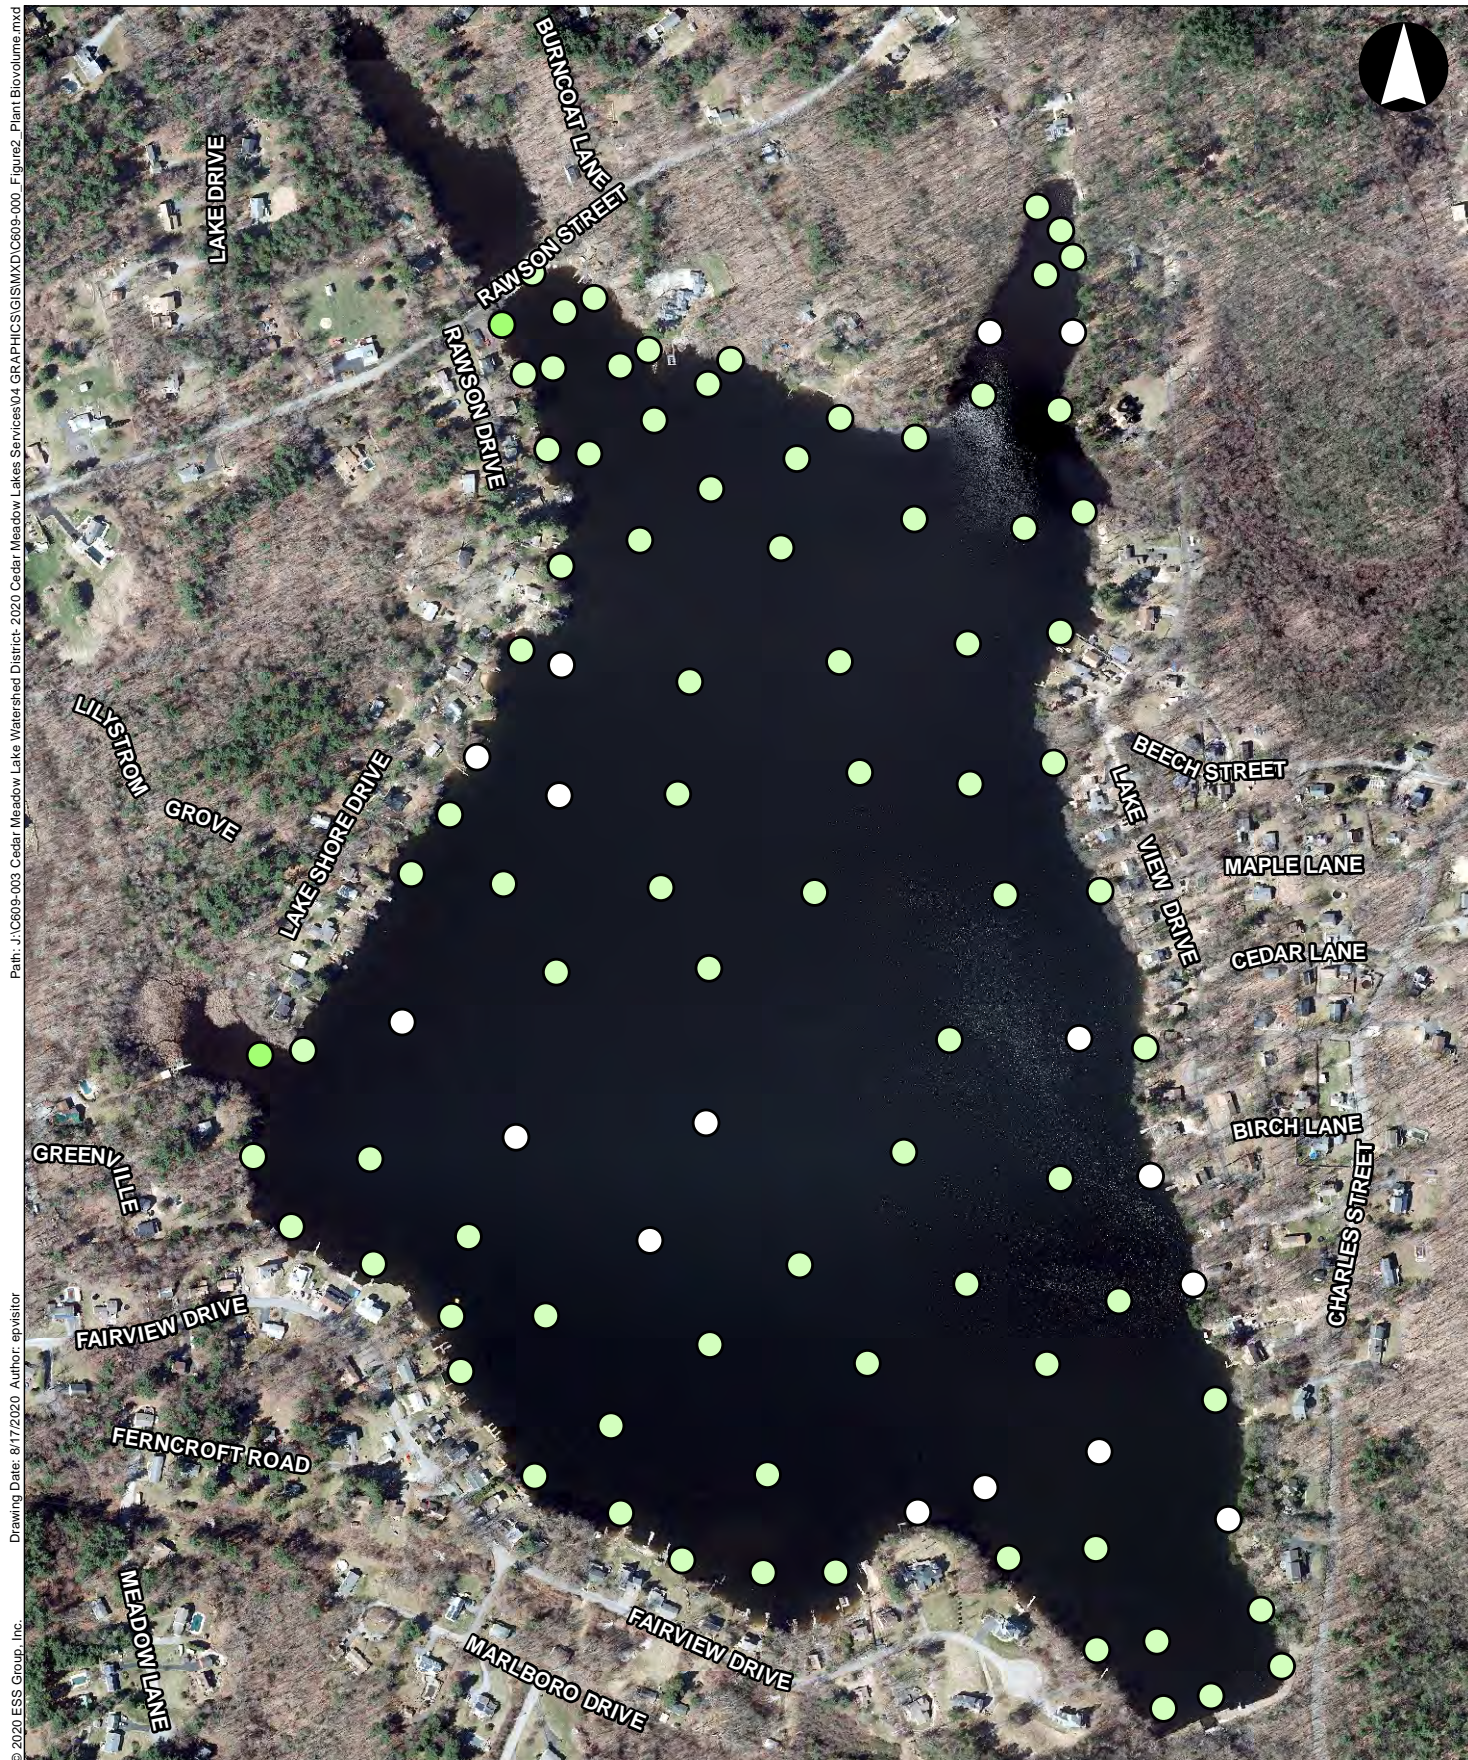
**Figure 2**

## **Aquatic Plant Biovolume** **August 6, 2020**

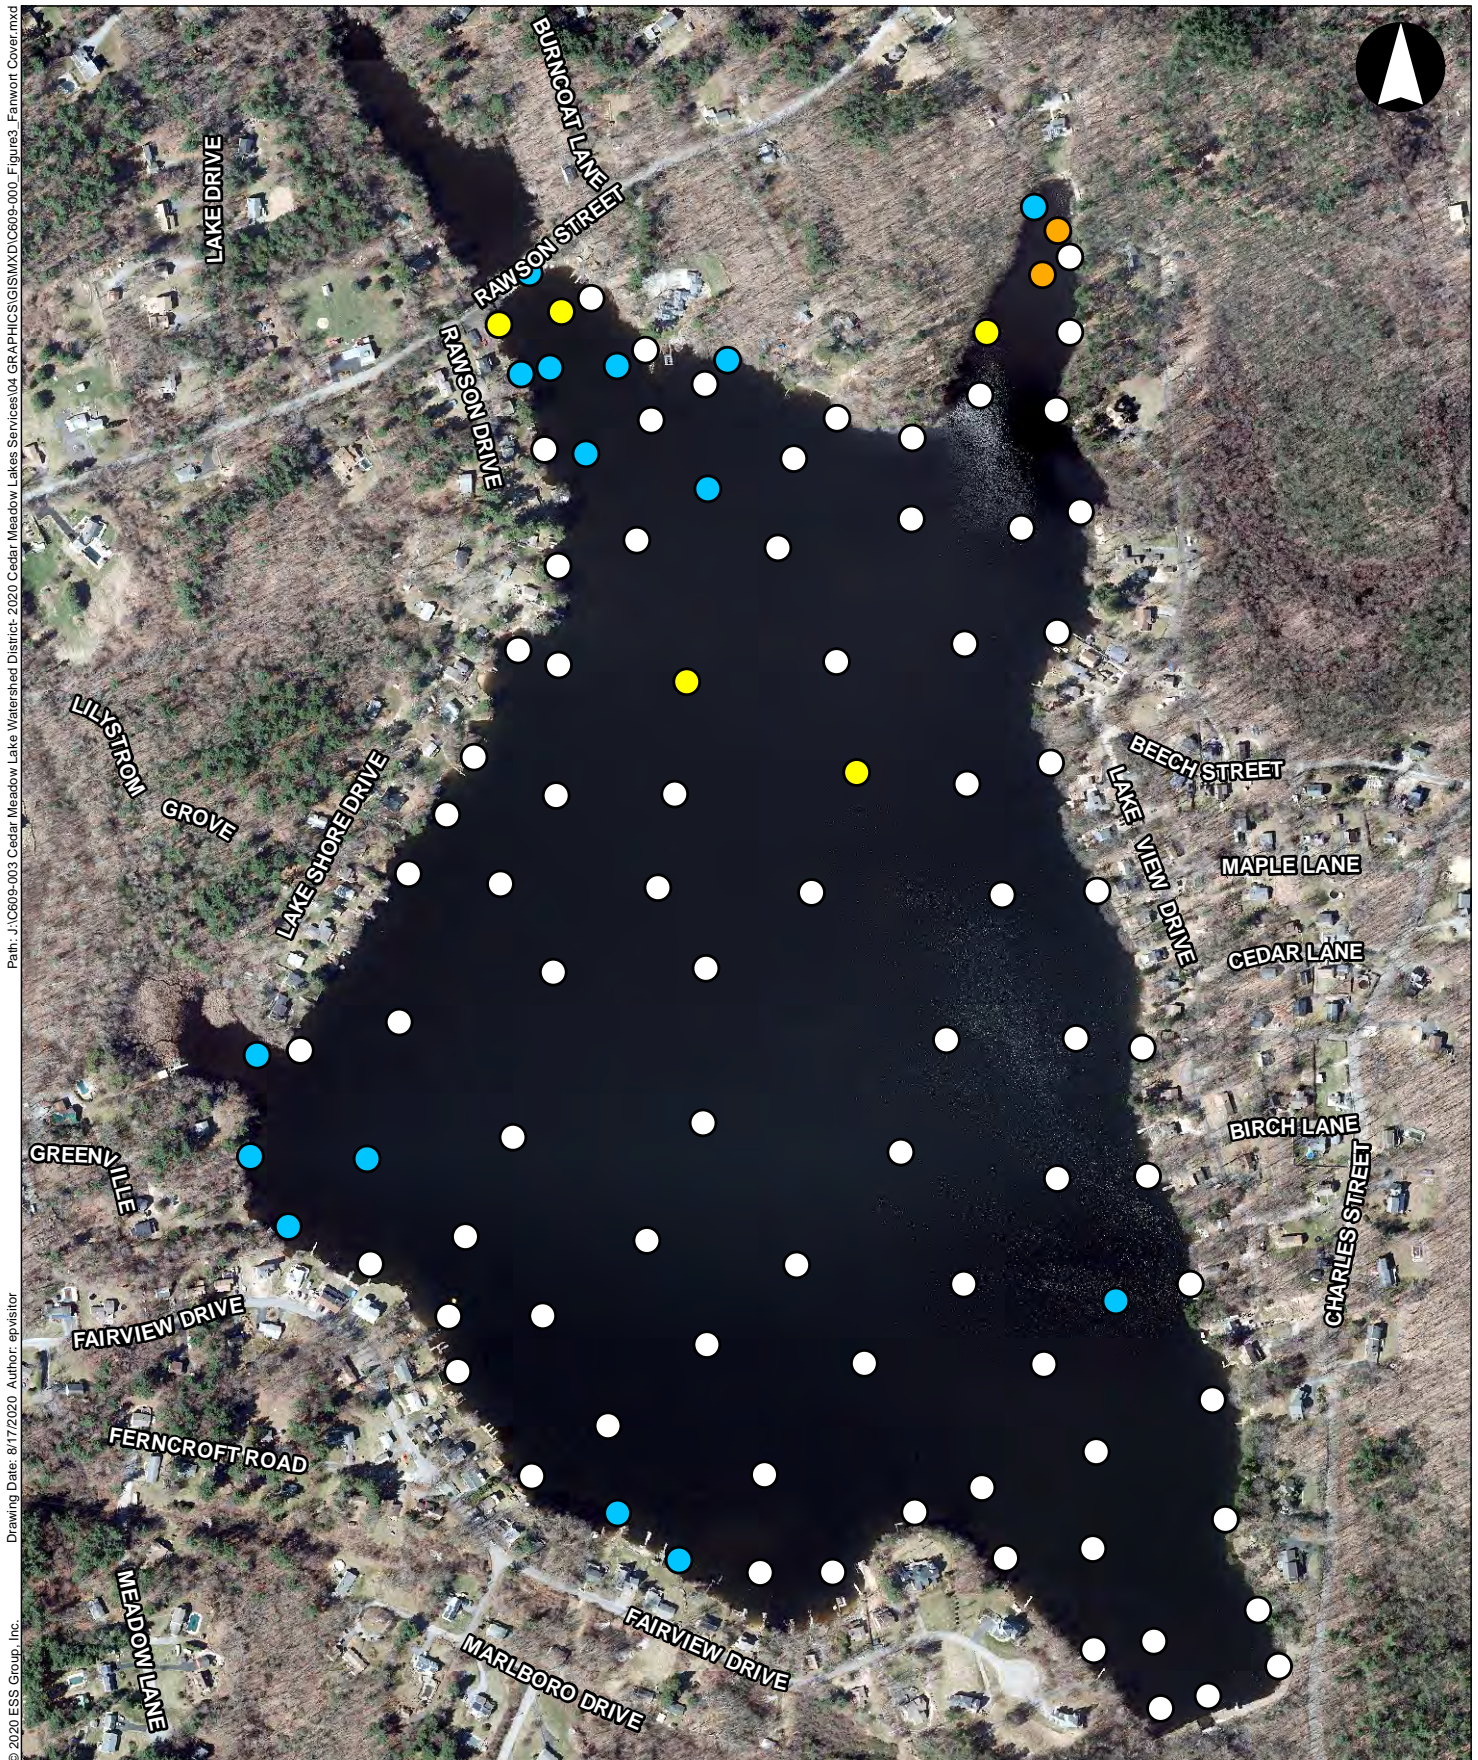
Figure 3

Fanwort Cover  
August 6, 2020

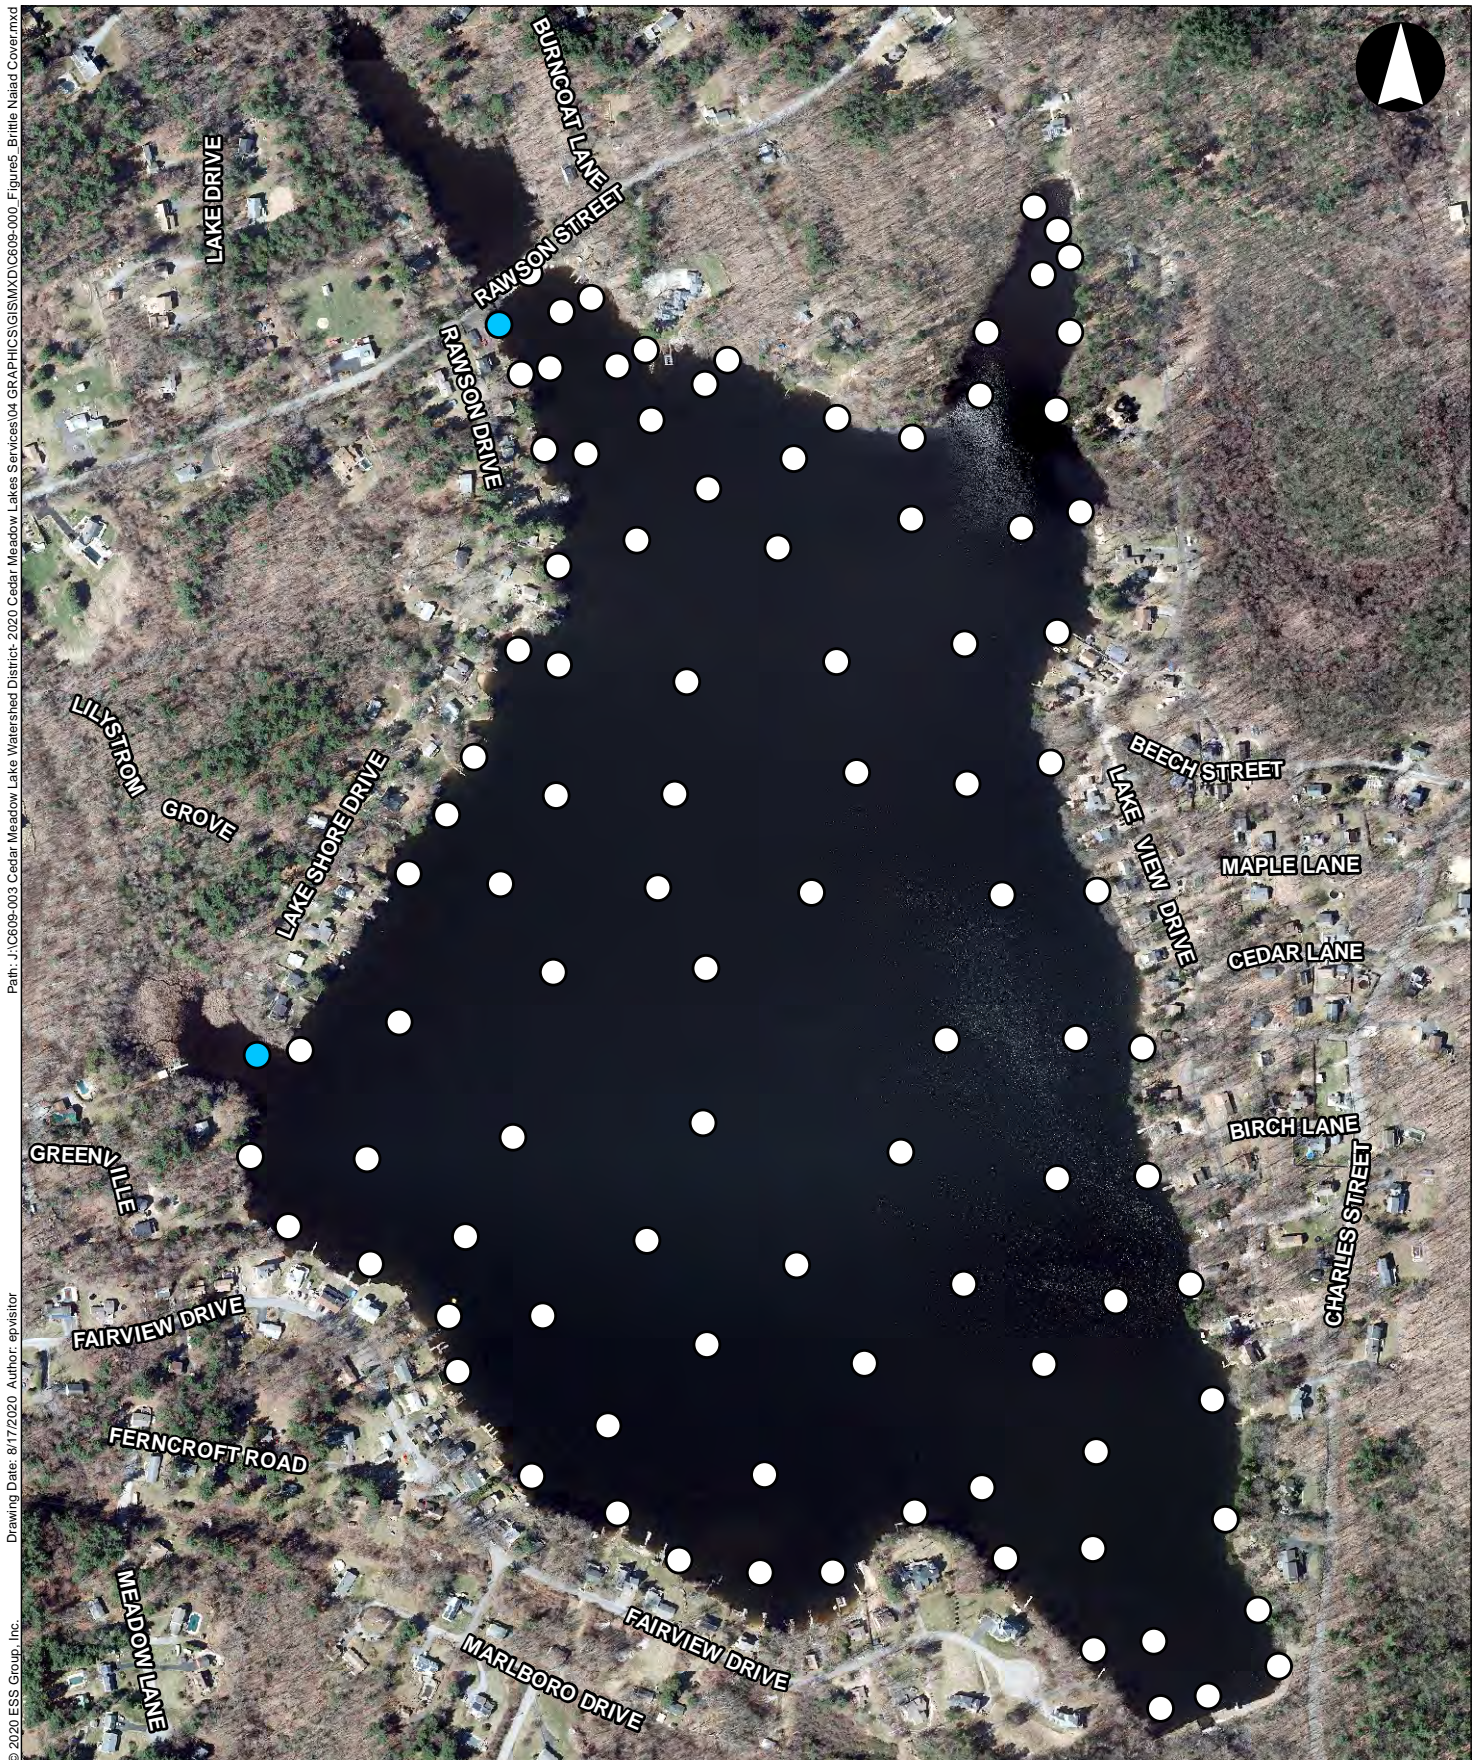
**Figure 5**

Path: J:\C609-003 Cedar Meadow Lake Watershed District - 2020 Cedar Meadow Lakes Services\04 GRAPHICS\GIS\MXD\C609-000\_Figure5\_Brittle Naiad Cover.mxd  
 Drawing Date: 8/17/2020 Author: epv:jsv  
 © 2020 ESS Group, Inc.

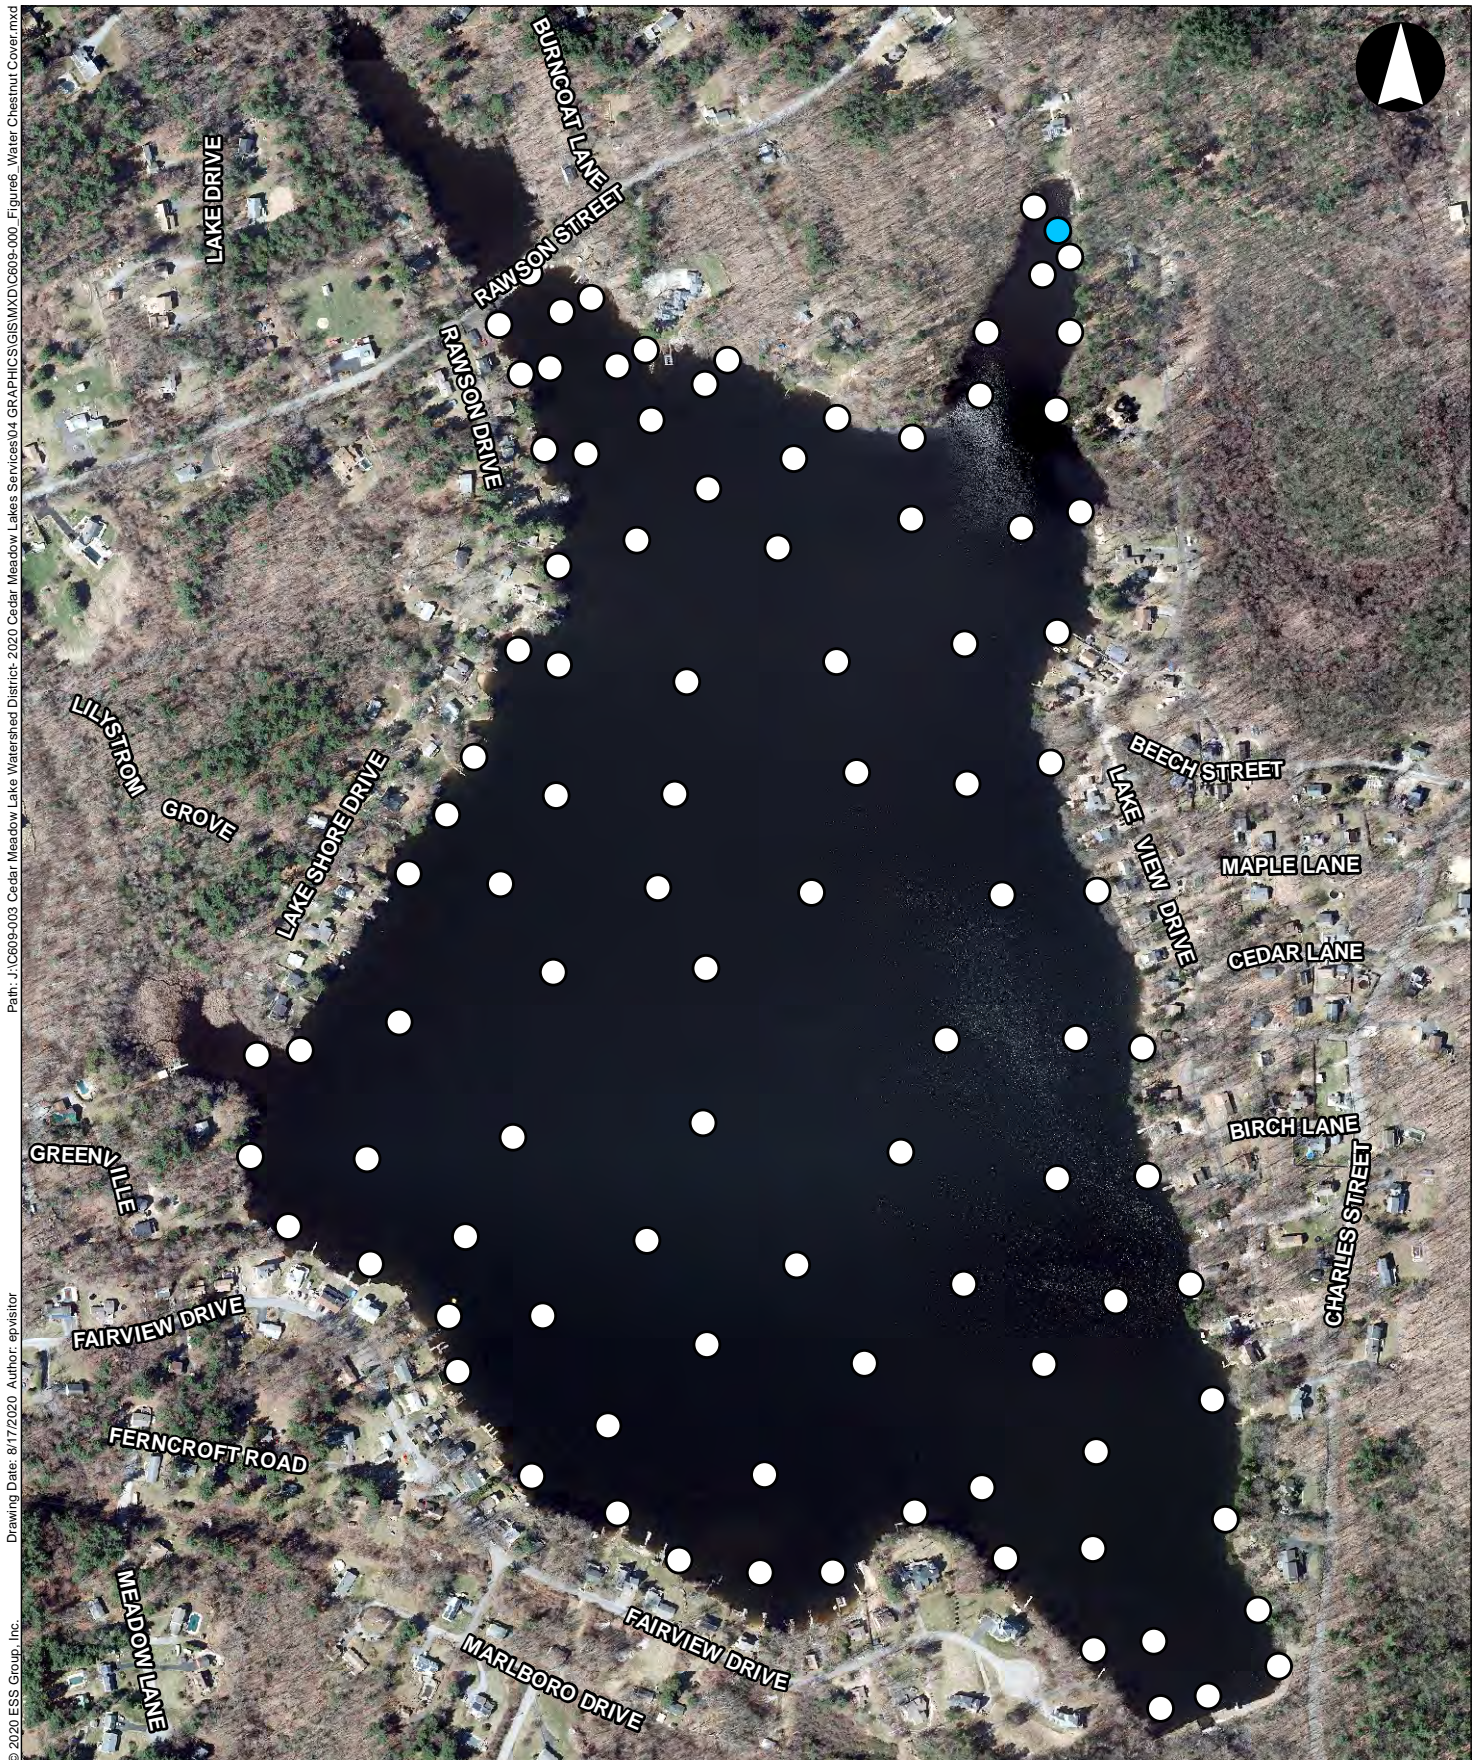
**Figure 6**

**Water Chestnut Cover**  
 August 6, 2020

**Hand Pulling of Water Chestnut.** As stated previously, ESS located and pulled two stems of water chestnut from the northeastern cove this year. Water chestnut can be effectively managed by hand pulling where it occurs at low densities. If effective control can be achieved early, the species can be prevented from spreading throughout the lake. Water chestnut floats on the water's surface, has a distinctive growth form and appearance, and is unlikely to be confused with any other aquatic plant species; these factors make the species an excellent candidate for an effective hand pulling effort by District volunteers. ESS recommends that the District undertake an aggressive monitoring and hand pulling effort for water chestnut beginning next year to manage this species in the lake. Hand pulling must be conducted prior to the end of July to ensure plants are removed before seeds are dropped. Pulled plant material must be composed at an upland location far from any waterbody, or sent to a landfill.

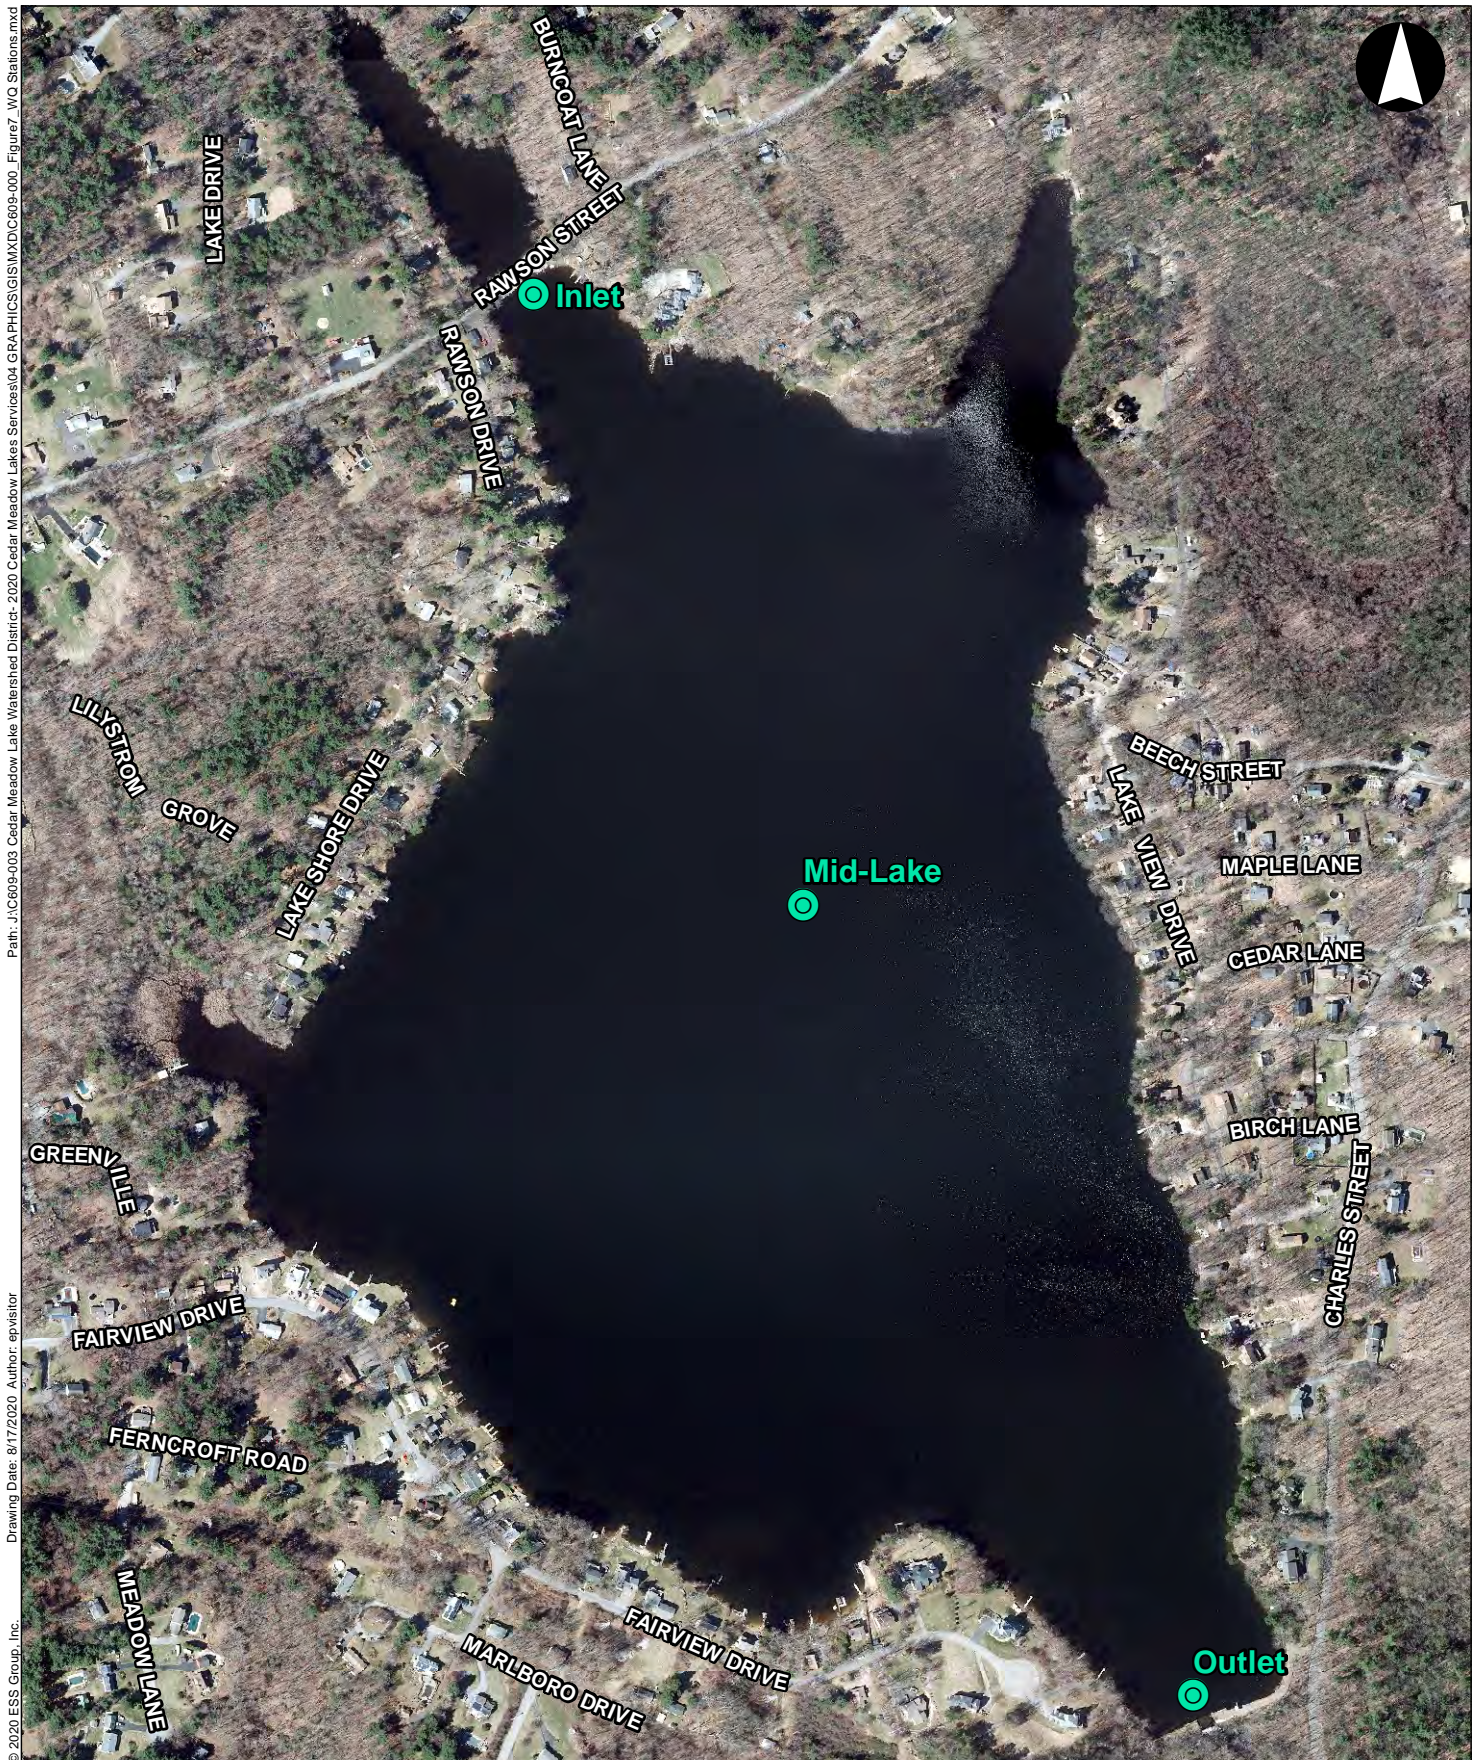
**Figure 7**

## **Water Quality Monitoring Stations** August 6, 2020

Water temperature, dissolved oxygen, and specific conductance were measured vertically through the water column at 0.5-meter intervals at three locations in the lake: the inlet, a mid-lake location, and the outlet (Table 2). These parameters were consistent both vertically (i.e., from the surface to the bottom) within each sampling location as well as horizontally between locations. Consistent water temperatures from the surface to the bottom indicate that Cedar Meadow Lake was not stratified during the time of sampling. Stratification occurs in some lakes due to a lack of mixing between surface and bottom waters, typically during the summer, and results in a warmer, well-oxygenated surface layer and a cooler bottom layer with lower dissolved oxygen concentrations. Given that sampling occurred in mid-summer, when lakes typically become stratified, it is likely that Cedar Meadow Lake does not become stratified for
