**Re: *Abbreviated Vegetation Survey and Recommendations – 2021  
Cedar Meadow Lake  
Leicester, Massachusetts  
ESS Project No. C609-003***

**Cedar Meadow Lake 2021**  
 Leicester, Massachusetts

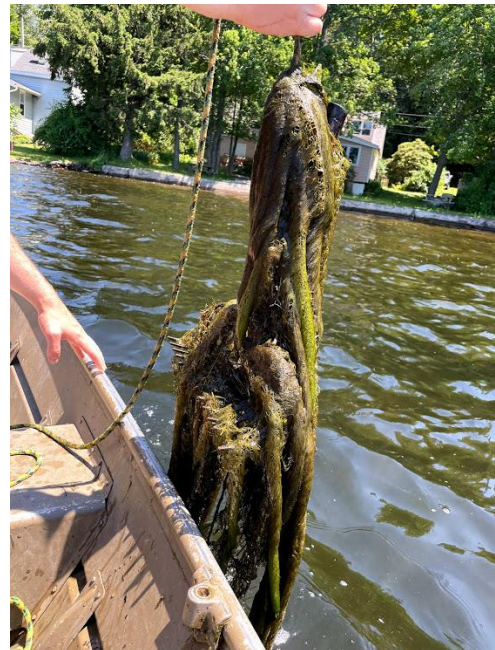
*Variable leaf milfoil stems on a plant sampling rake at Cedar Meadow Lake, June 30, 2021.*

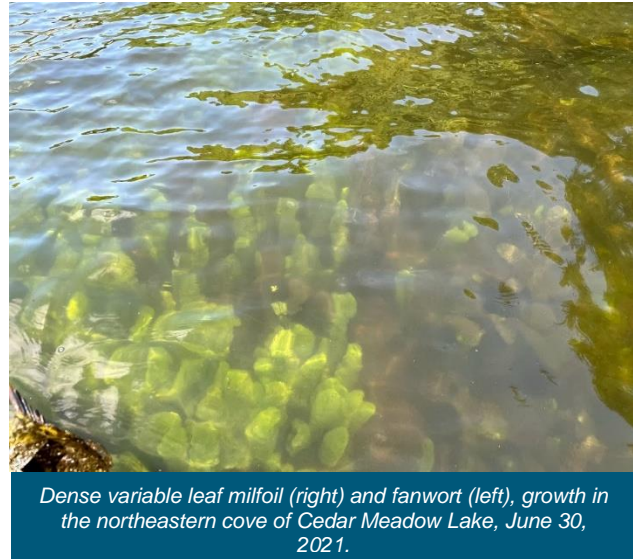
*Dense variable leaf milfoil (right) and fanwort (left), growth in the northeastern cove of Cedar Meadow Lake, June 30, 2021.*

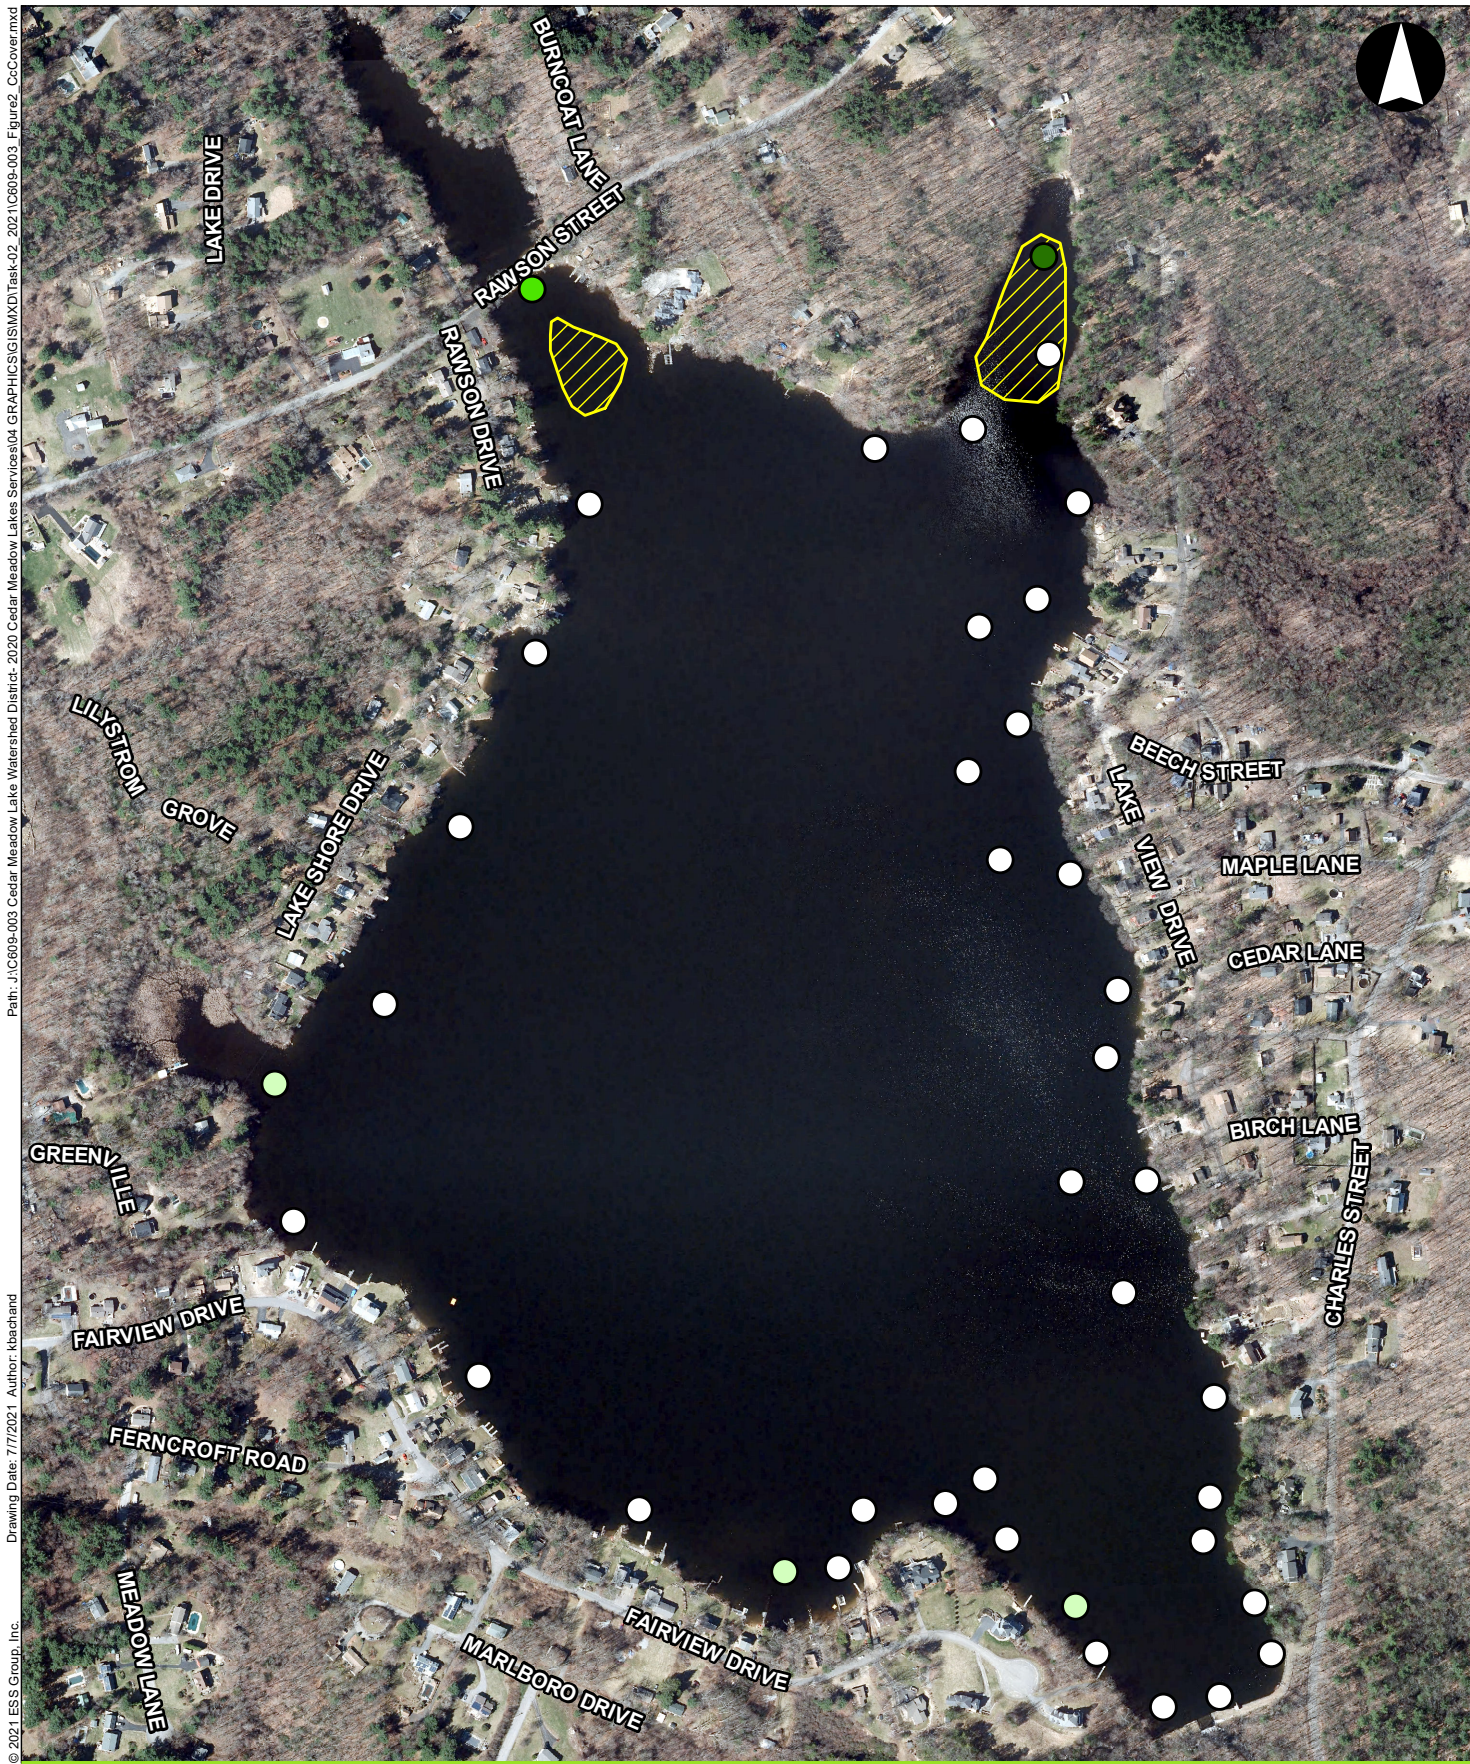
**Figure 2**

The invasive weed fanwort was also observed during the abbreviated vegetation survey. Though a few, very small, isolated patches of this species were observed in the vicinity of the eastern and southern shorelines of the lake, fanwort growth was primarily concentrated in the two northern coves (Figure 2). Dense fanwort beds occupied much of these coves, abutting and distributed amongst dense patches of variable leaf milfoil.

Fanwort distribution is similar to conditions observed in August 2020, and coverage remains below levels observed prior to initial treatment of the lake with herbicides in 2015.

**Fanwort Cover**  
June 30, 2021

Treatment using Clipper and Reward is the most economical option to address the invasive weeds at Cedar Meadow Lake. Both Clipper and Reward are contact herbicides, which can be applied to targeted areas of dense growth. Clipper and Reward were last applied to 22.7 acres of Cedar Meadow Lake on June 17<sup>th</sup>, 2015 and were noted to provide effective control of the target species.

Use of Sonar is not recommended at this time. Sonar is a systemic herbicide which requires whole-lake application early in the growing season. Though Sonar application can be highly effective against fanwort if appropriate concentrations are maintained, this herbicide is an expensive management option.
