Lake Assessment and Management Recommendations - 2022

November 15, 2022

Cedar Meadow Lake

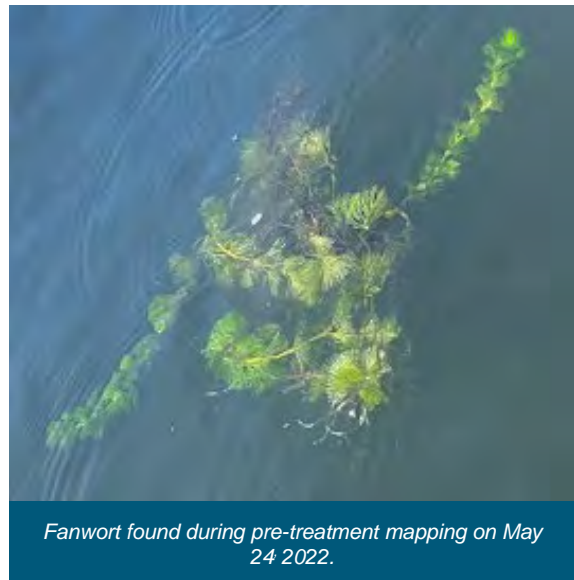
Approximately 9.9 acres of fanwort beds (areas mapped as >25% cover) within Cedar Meadow Lake were treated with Clipper (flumioxazin) on June 14, 2022.

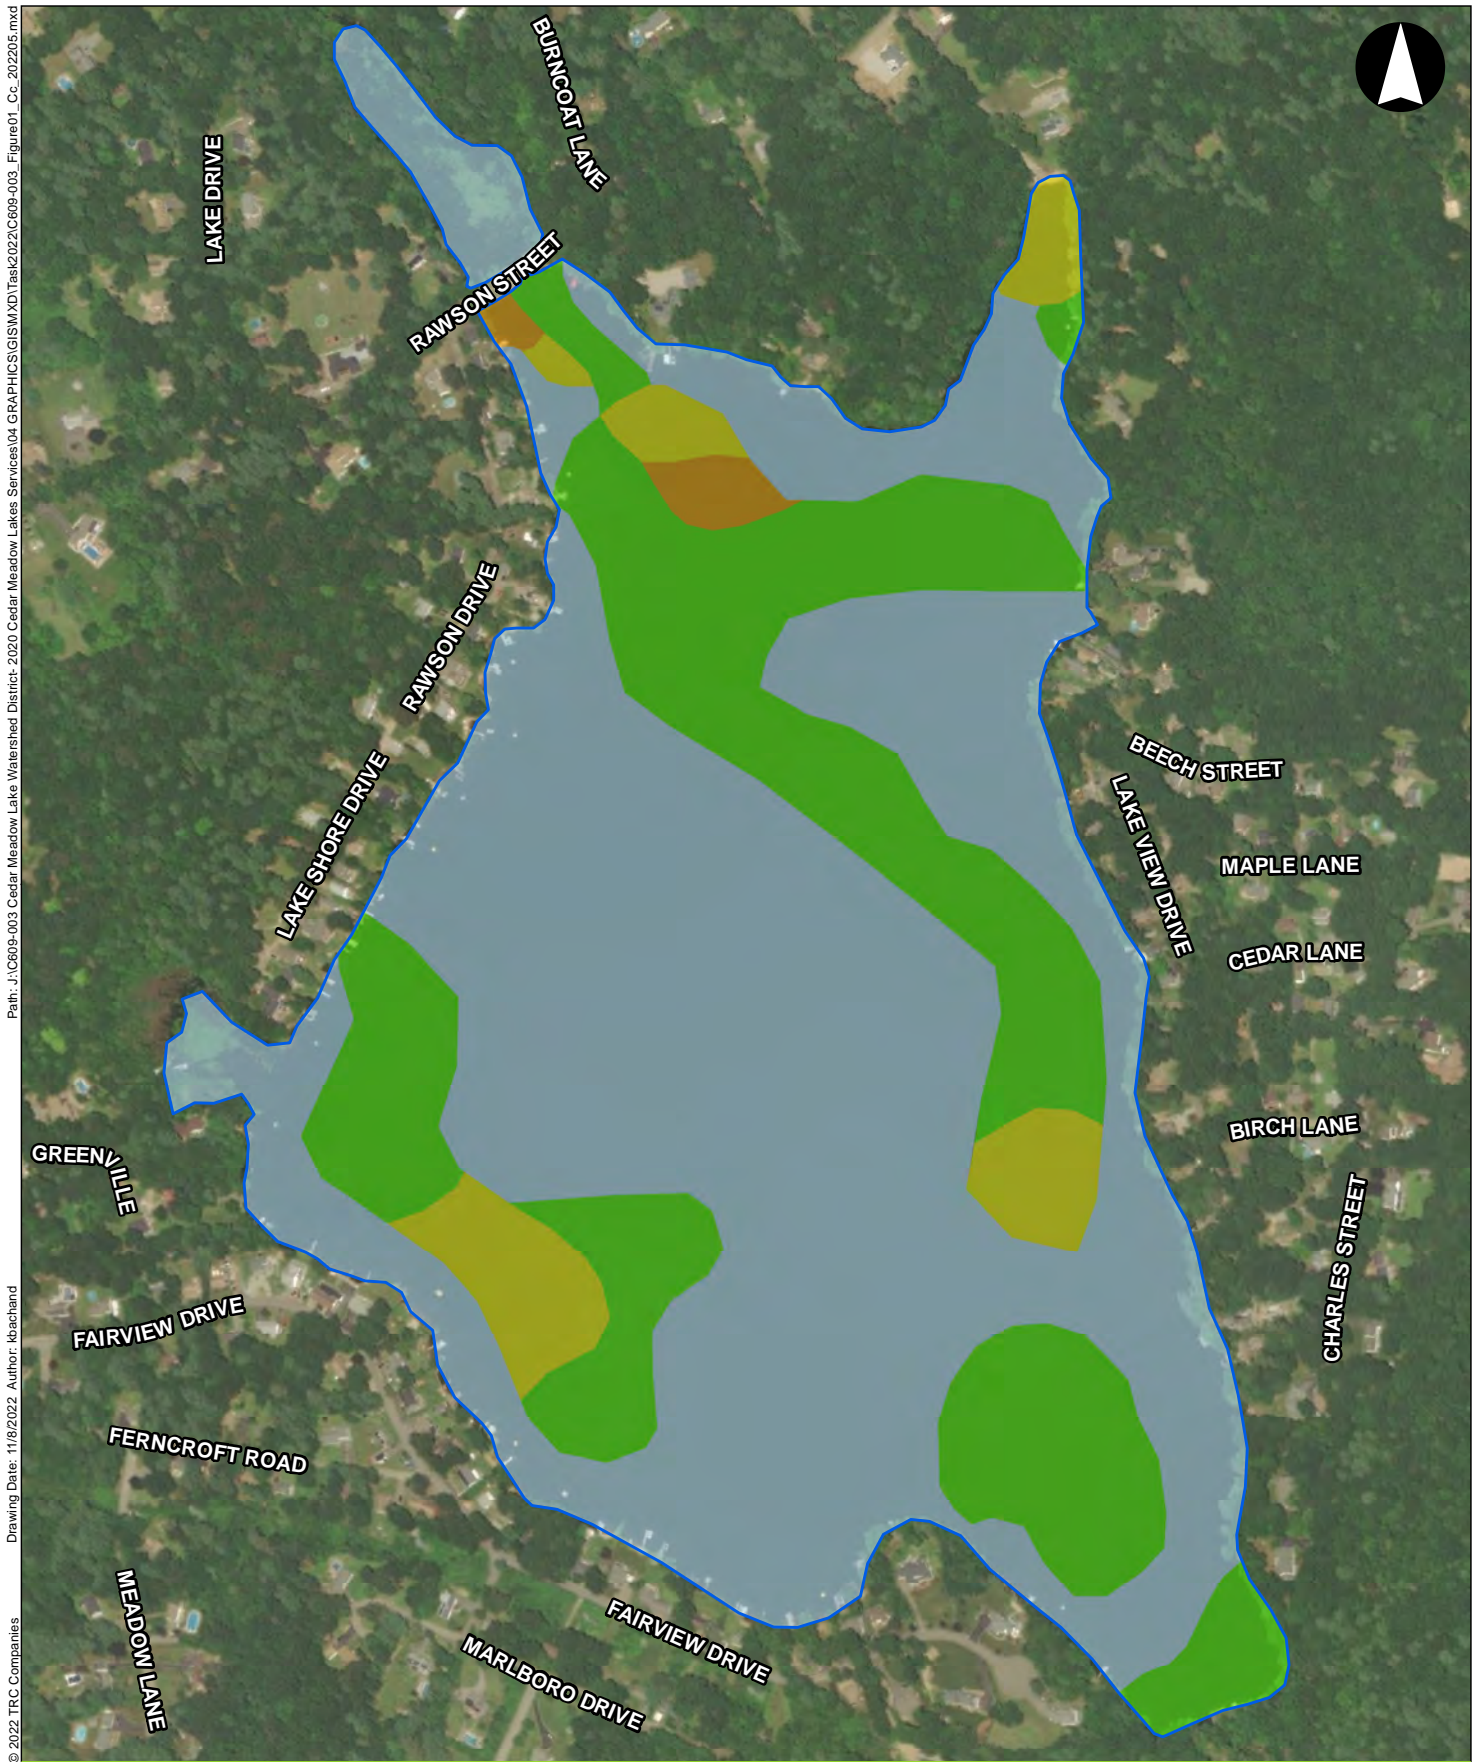
Figure 1

In 2022, fanwort was the most widespread and abundant invasive macrophyte species in Cedar Meadow Lake. During pre-treatment mapping this species was present in approximately 49.2 acres of the lake, and coverage exceeded 25% in approximately 9.9 acres (Figure 1). Fanwort was found growing in much of the lake, but growth was generally most dense in the area of the northeastern cove. This species was present in shoreline areas but was also abundant in deeper waters.

Fanwort Cover
May 24, 2022

0% (96.4 Acres)	51% - 75% (1.5 Acres)
1% - 25% (39.3 Acres)	76% - 100% (0 acres)
26% - 50% (8.4 Acres)

To provide control of fanwort and variable-leaf milfoil within Cedar Meadow Lake, we recommend a whole-lake application of the systemic herbicide fluridone (trade name Sonar) in 2023. Sonar acts as a carotenoid biosynthesis inhibitor, effectively leading to the depletion of chlorophyll. This

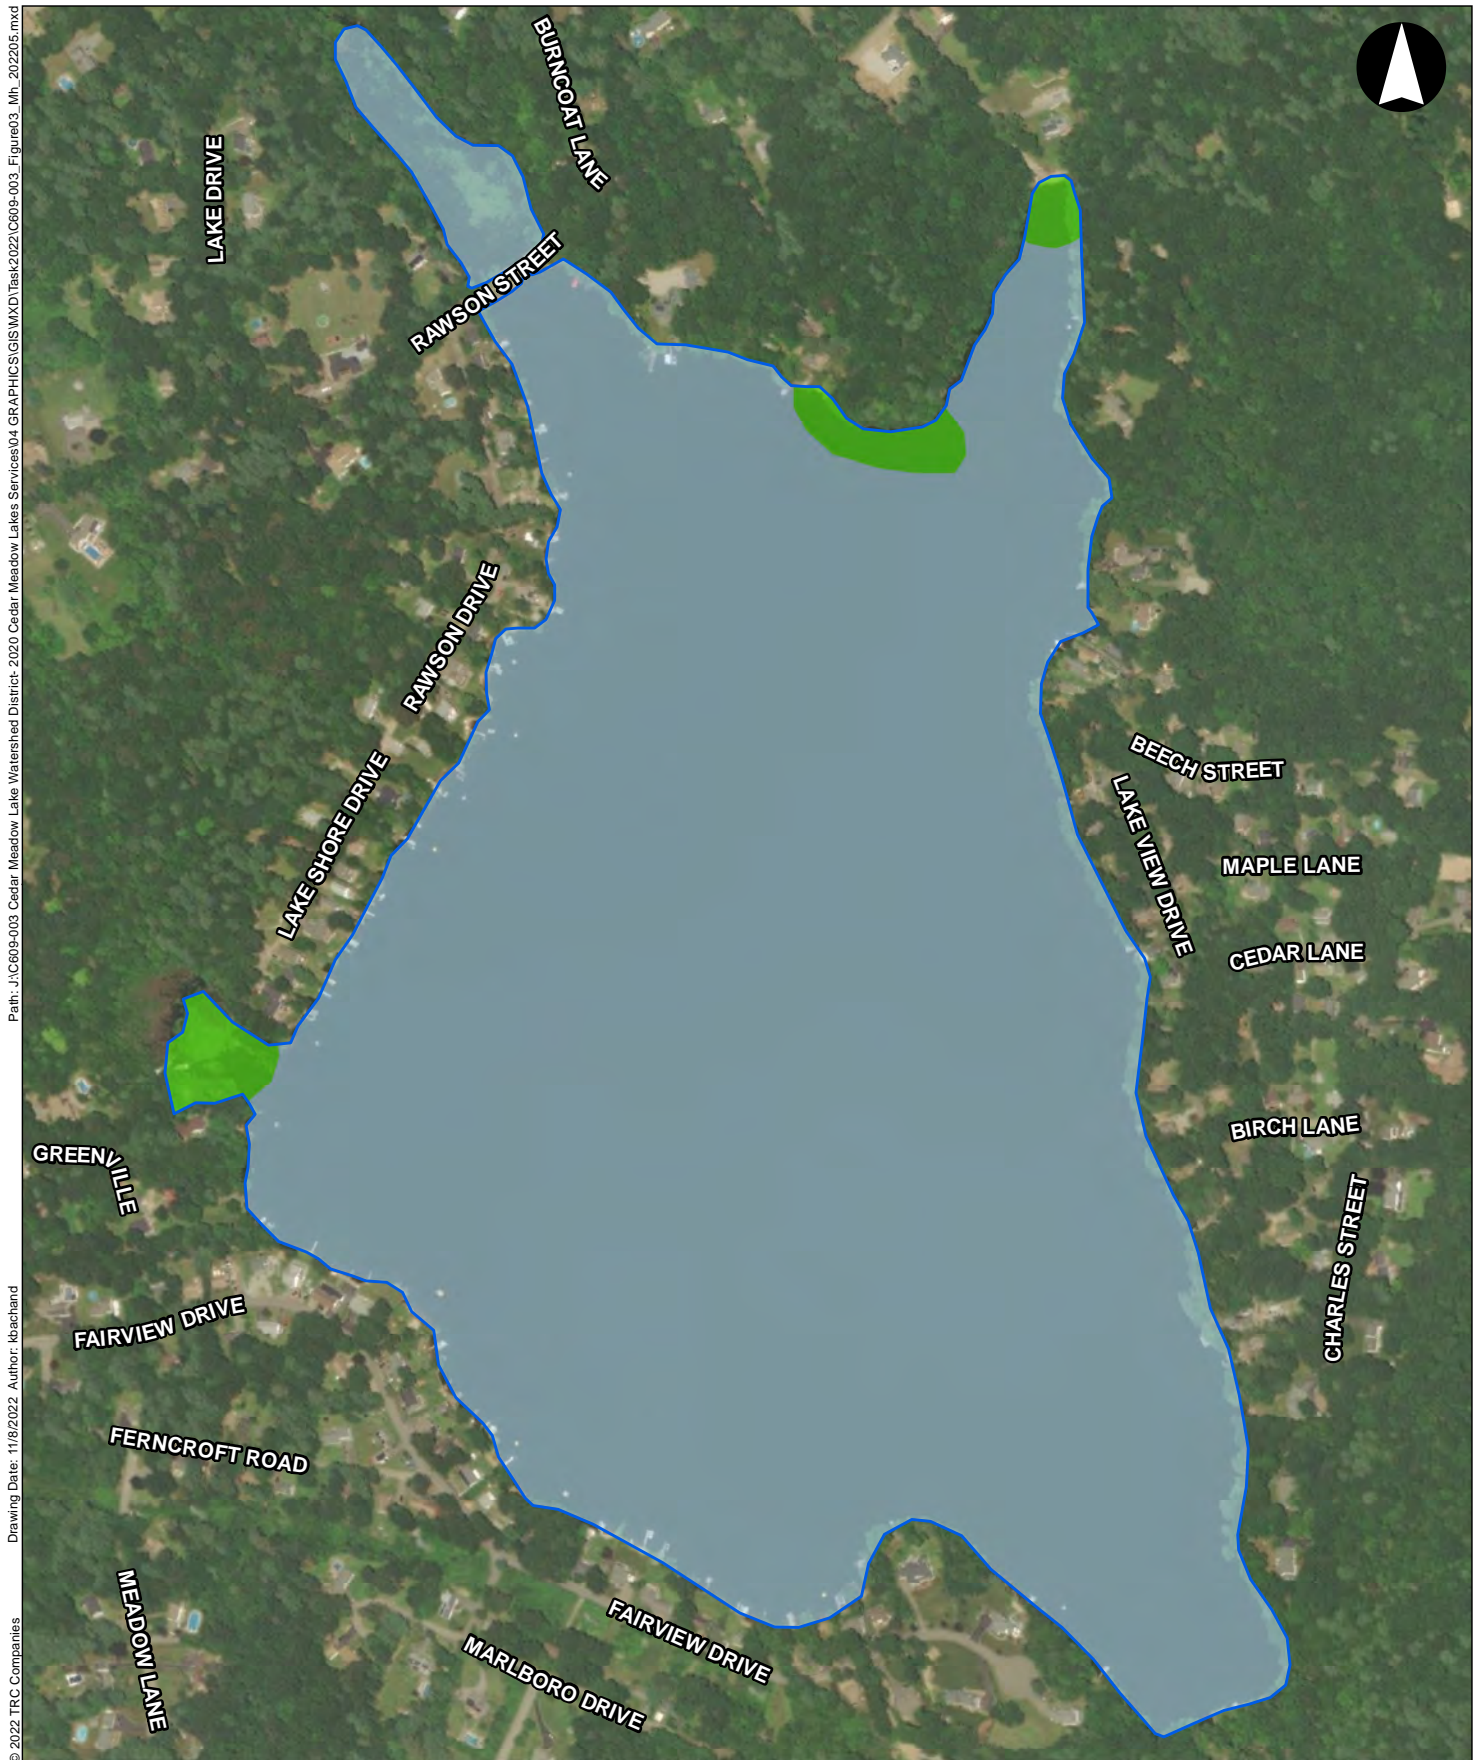
Figure 3

Only three acres of variable-leaf milfoil growth was documented in Cedar Meadow Lake during the pre-treatment survey conducted on May 24, 2022 (Figure 3). This represents a notable decrease in density compared to 2021, when this species was present in approximately 11 acres of the waterbody. This shift may indicate that variable-leaf milfoil is being outcompeted by fanwort in Cedar Meadow Lake.

Variable Leaf Milfoil Cover
May 24, 2022

- 0% (142.5 Acres)
- 1% - 25% (3.0 Acres)
- 26% - 50% (0 acres)
- 51% - 75% (0 acres)

All mapped areas of variable-leaf milfoil growth (approximately 3 acres) were treated with Reward (diquat dibromide) on June 14, 2022.

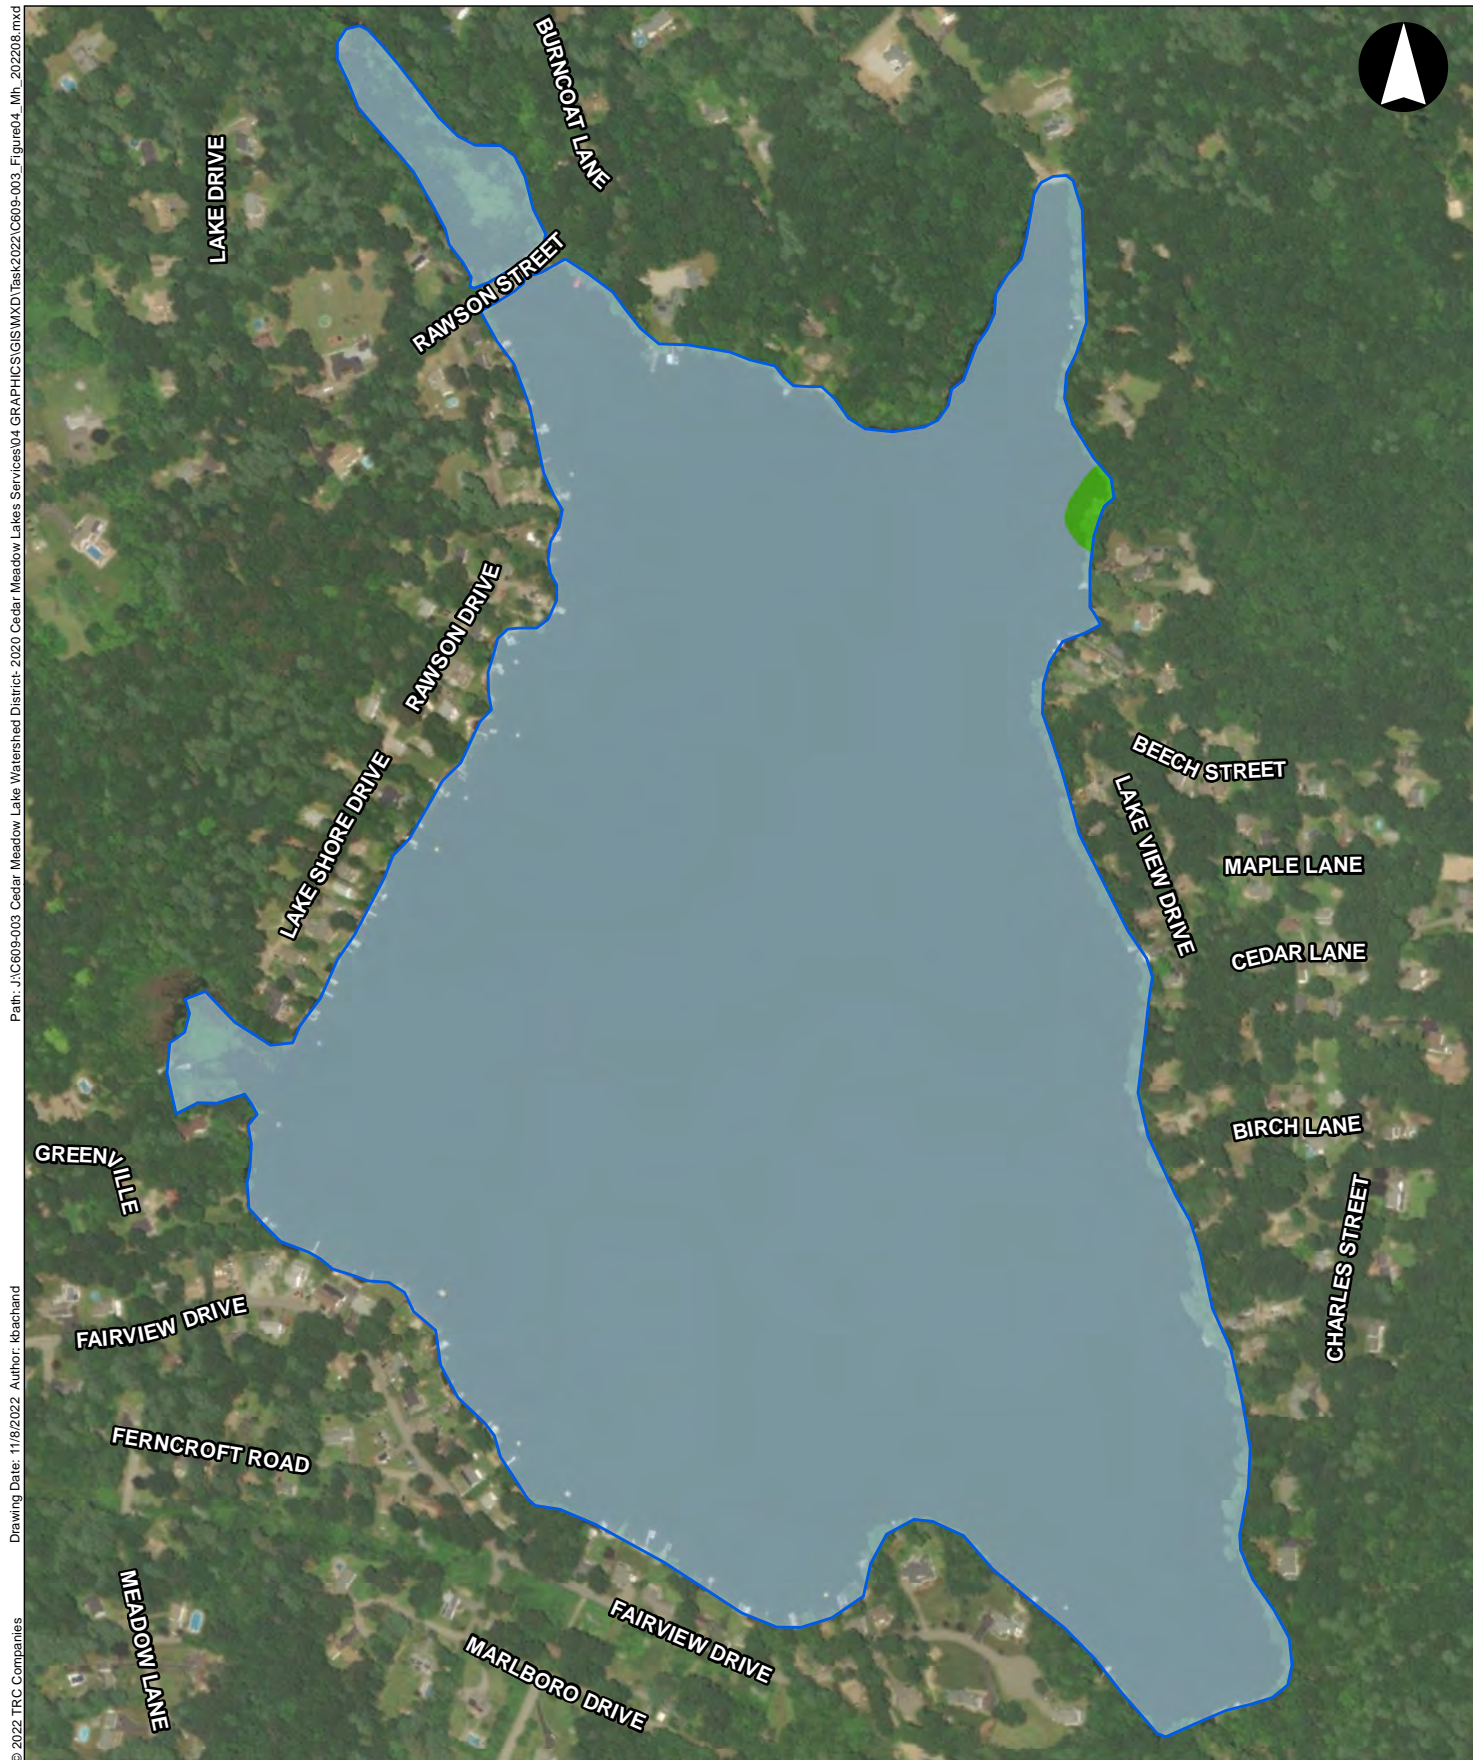
Figure 4

During the post-treatment mapping event on August 16, variable-leaf milfoil was not observed in any of the treated areas but was found in one small (~0.4 acre) patch located along the western shoreline (Figure 4).

Variable Leaf Milfoil Cover
August 16, 2022

- 0% (145.1 acres)
- 1% - 25% (0.4 acres)
- 26% - 50% (0 acres)
- 51% - 75% (0 acres)
