EMERGENCY ACTION PLAN

Cedar Meadow Lake Dam

Leicester, Worcester County, Massachusetts

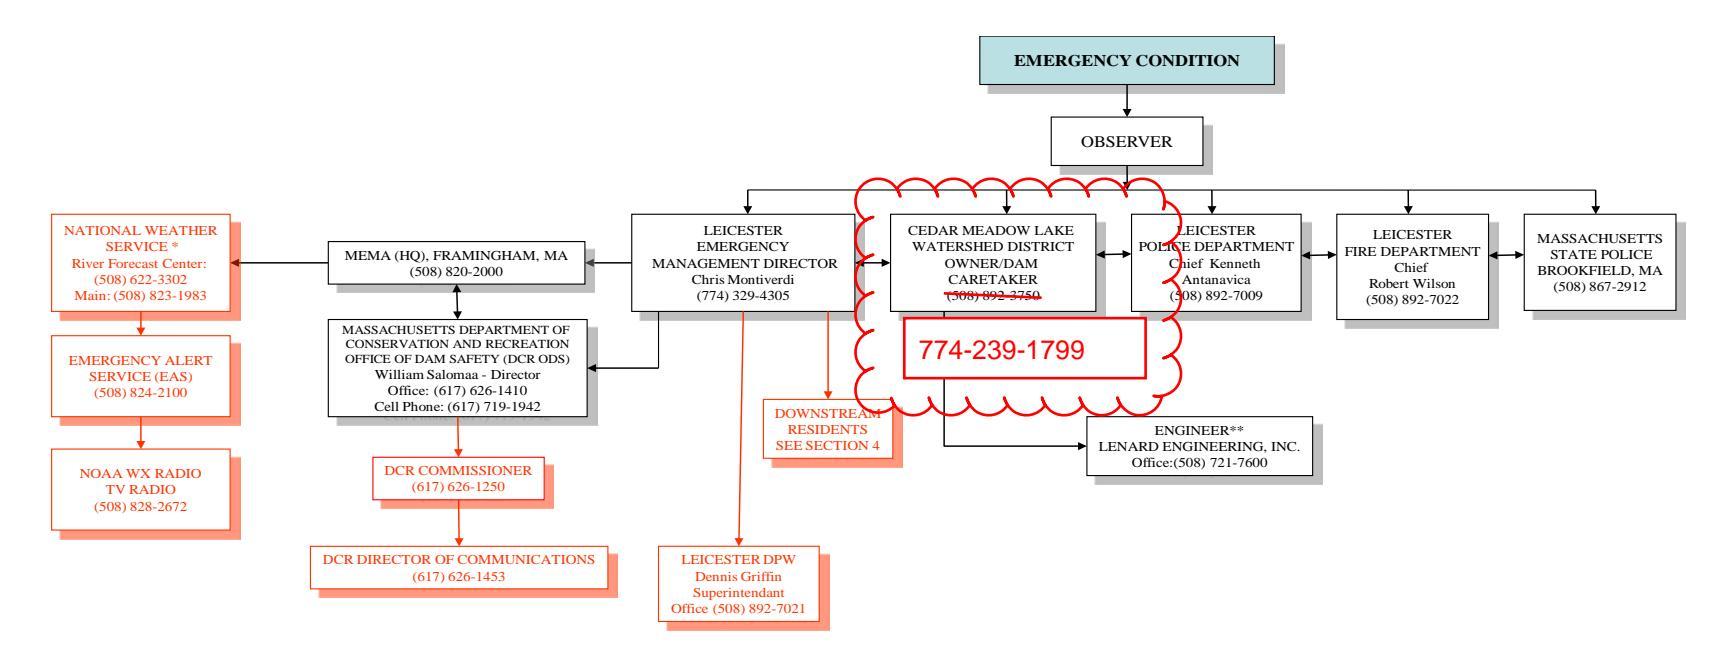
CEDAR MEADOW LAKE DAM NOTIFICATION FLOWCHART

Phase I: NOTIFICATION PATH IF POTENTIAL FAILURE IS DEVELOPING (DAM SAFETY WATCH)

Phase II: NOTIFICATION PATH IF FAILURE IS IMMINENT OR HAS OCCURRED (DAM SAFETY WARNING)

* CALL THE NATIONAL WEATHER SERVICE IF IT IS NECESSARY TO BROADCAST THE EVACUATION ON TELEVISION AND RADIO. THE NATIONAL WEATHER SERVICE WILL CALL THE FIRE DEPARTMENT TO VERIFY THE EMERGENCY. ** LENARD EXIDERTING, INC. SHOULD BE CONTACTED IMMEDIATELY TO ASSESS THE SITUATION.

The Notification Flowchart (located at the front of this report, before the table of contents) indicates the chain of communication to be followed in the event of an Emergency. The Notification Flowchart indicates a Phase I and Phase II type of notification to be implemented depending on the emergency classification level (Emergency Condition Watch or Dam Failure Warning) as determined necessary based upon the judgment of the personnel monitoring the emergency condition at the dam (see Section 4 for additional descriptions).

- <u>Dam Safety Watch:</u> "Potential failure is developing": This is a situation where a failure may eventually occur if left unattended. This situation will require a Phase I response with continuous monitoring of the situation.
- <u>Dam Failure Warning:</u> "Failure is Imminent or has occurred": This is a situation where a failure either has occurred, is occurring, or is just about to occur. This situation will require Phase I and II responses that will proceed with evacuation procedures.

During the highest emergency level (Dam Failure Warning), procedures are to evacuate the downstream residents using a combination of the telephone, augmented by police cruising the area broadcasting the evacuation message and going door to door to homes that cannot be reached by telephone. To ease this burden somewhat, the National Weather Service can be alerted at (508) 823-1983 and they will make a general broadcast about the evacuation over the airways. *The National Weather Service will call the Fire Department to verify the emergency. Therefore, the Fire Department should be called before the National Weather Service is contacted. MEMA can also be contacted to activate the Emergency Alert Service.*
